BRIDGE INSPECTION REPORT CITY OF GOSHEN, INDIANA

PHASE I - 2020

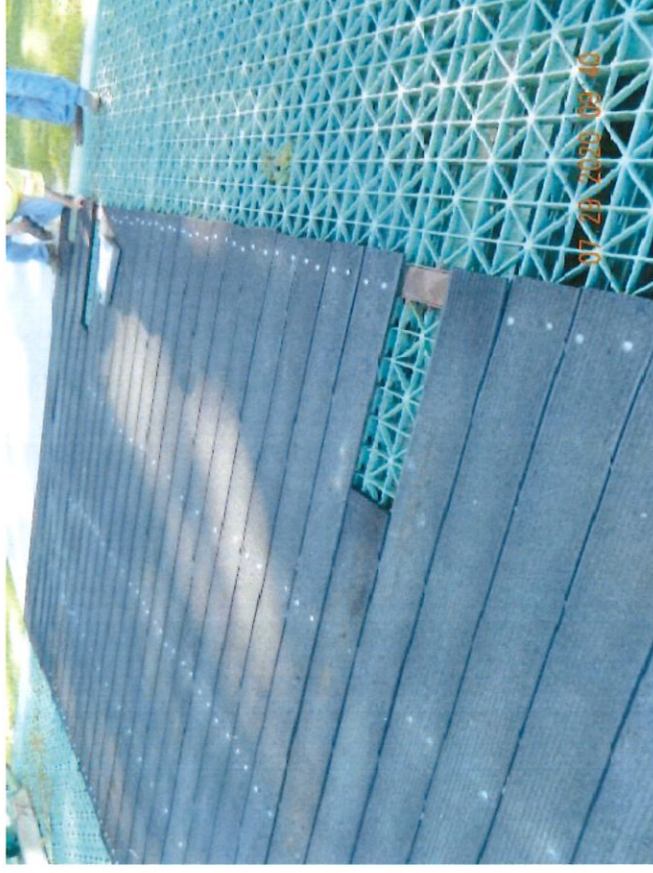
TYP. RUBBER MAT PIECES MISSING

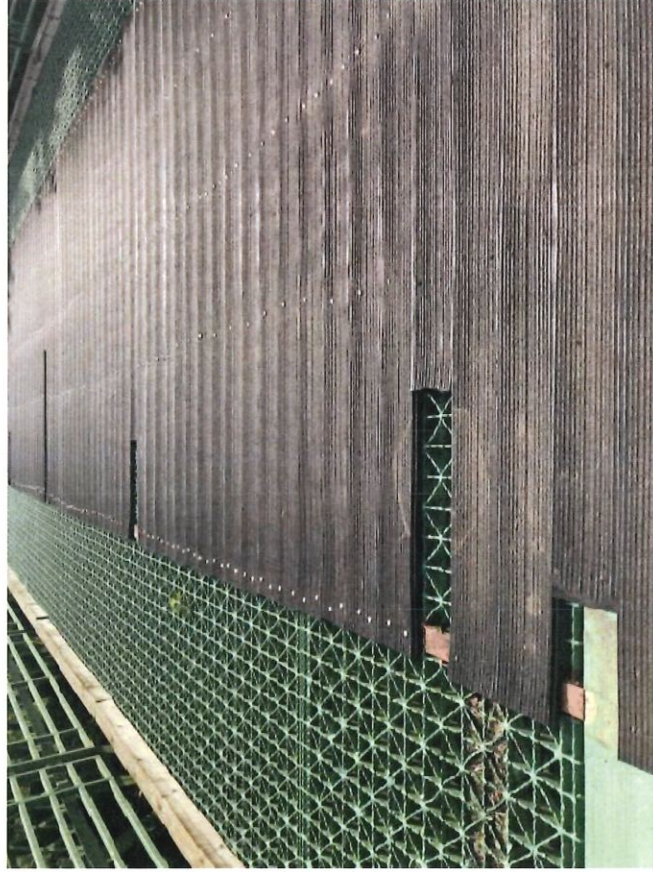
TYPICAL CONDITION OF RUBBER MAT

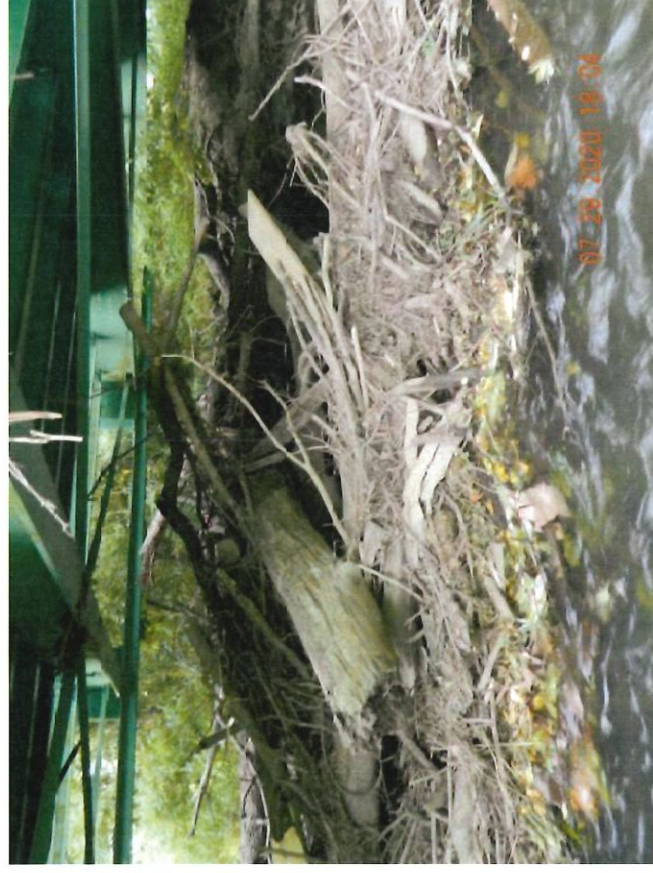
HEAVY DEBRIS IN CHANNEL

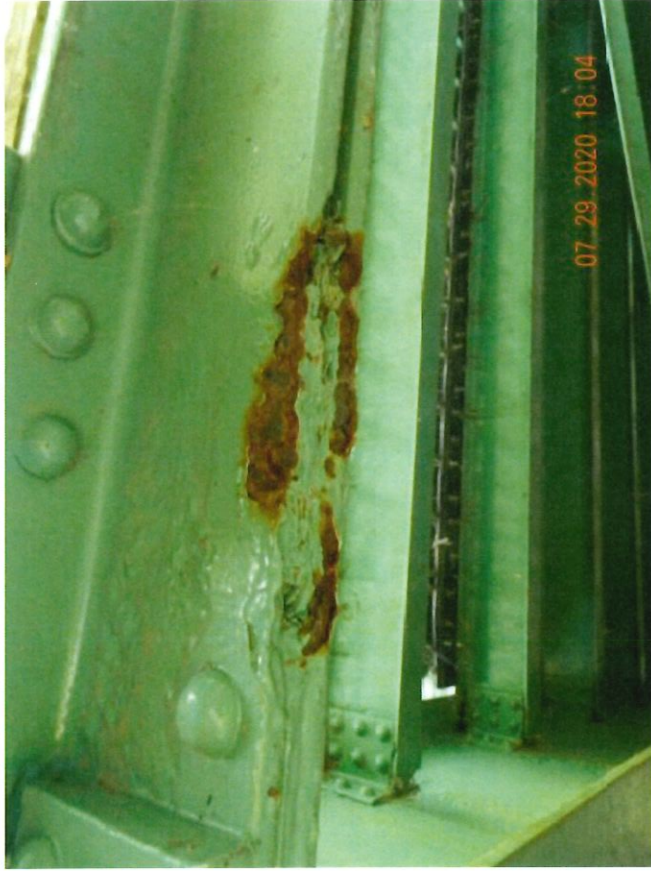
TYP. PACK RUST AT LOWER CHORD OF TRUSS

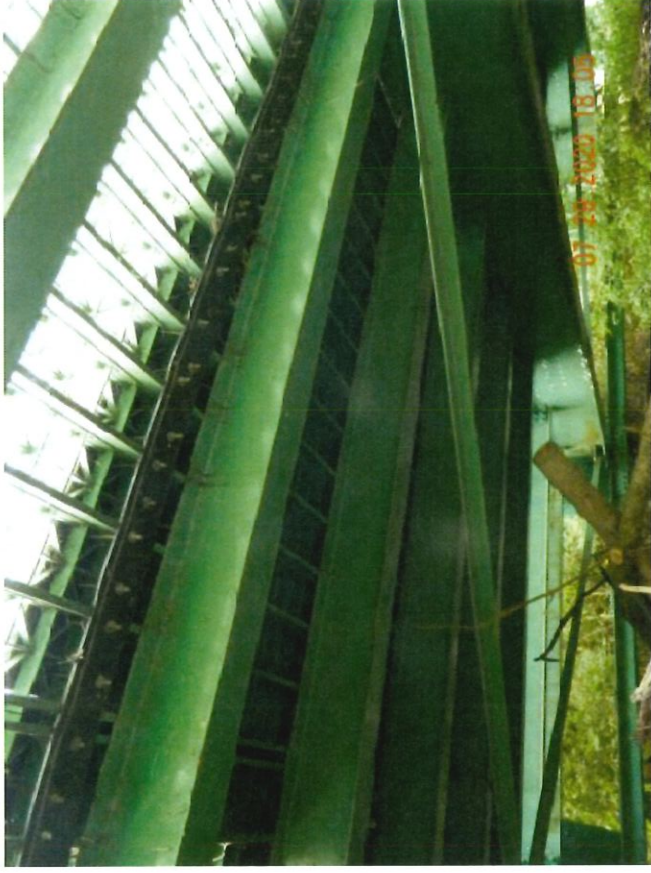
TYPICAL UNDERSIDE OF BRIDGE

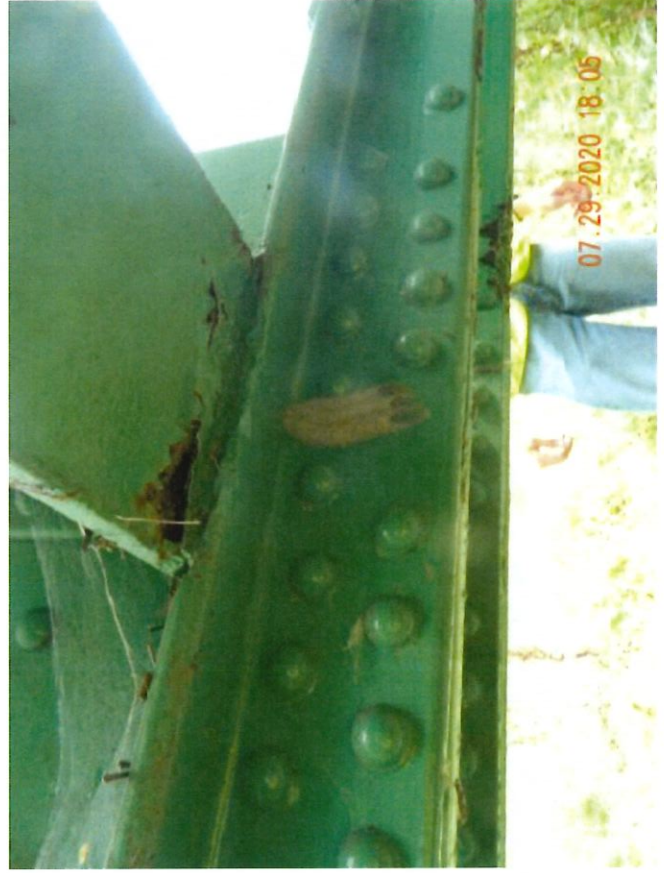
TYP. PACK RUST AT FLOORBEAM TO LOWER CHORD CONN.

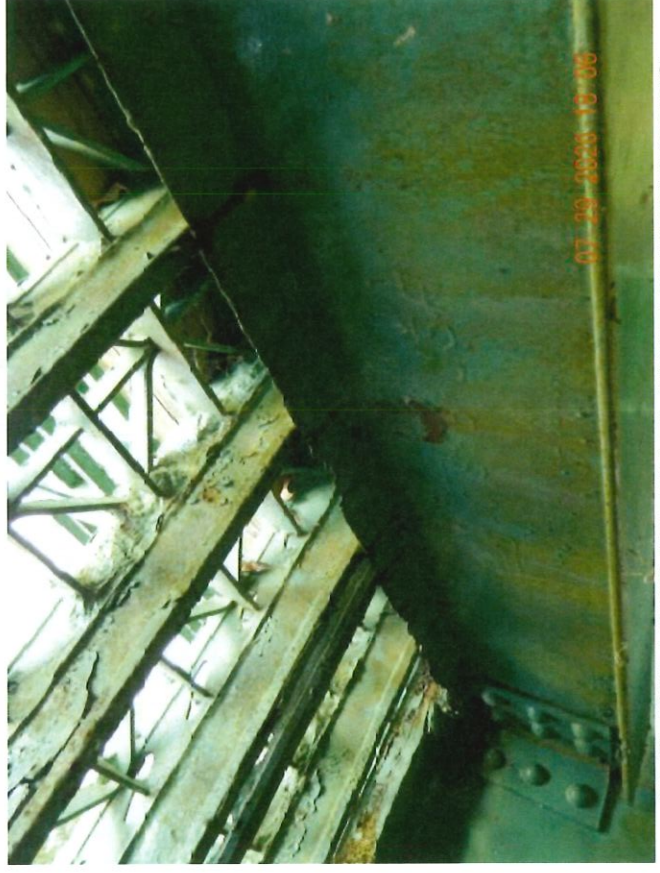
SECTION LOSS IN TOP FLANGE OF STRINGERS

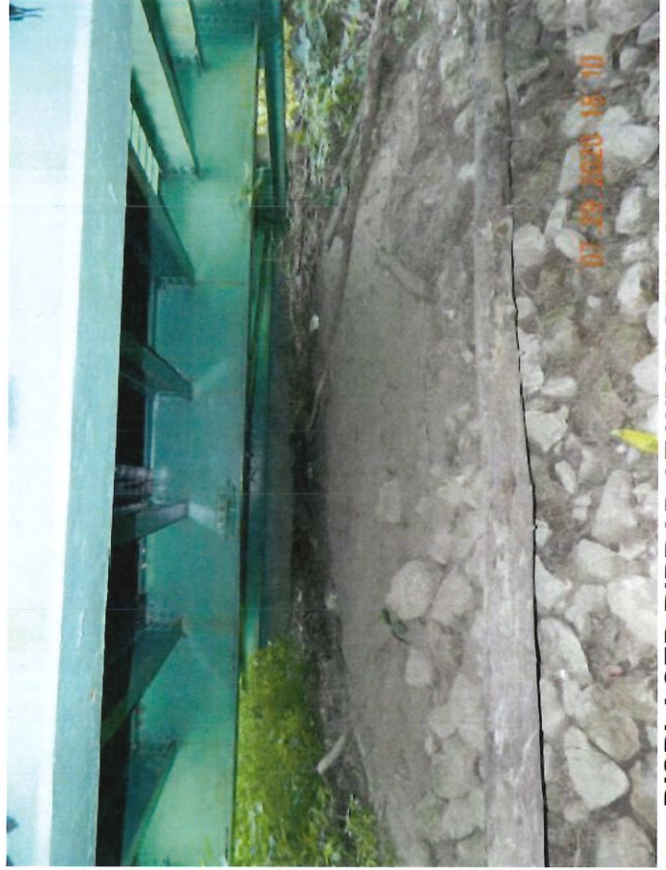
REPLACED RIPRAP AT WEST SPILLSLOPE

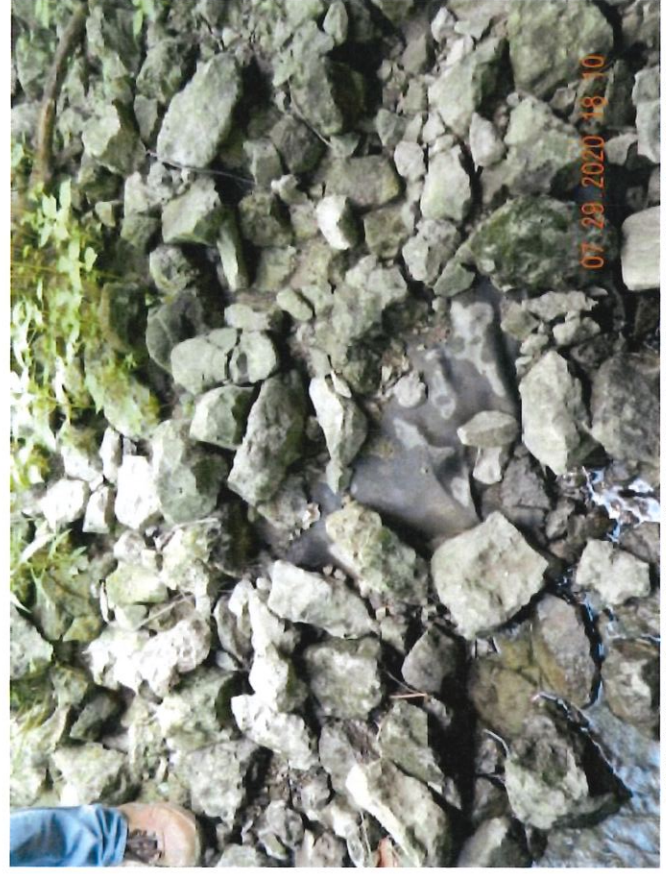
EXPOSED GEOTEXTILES AT WEST SPILL SLOPE

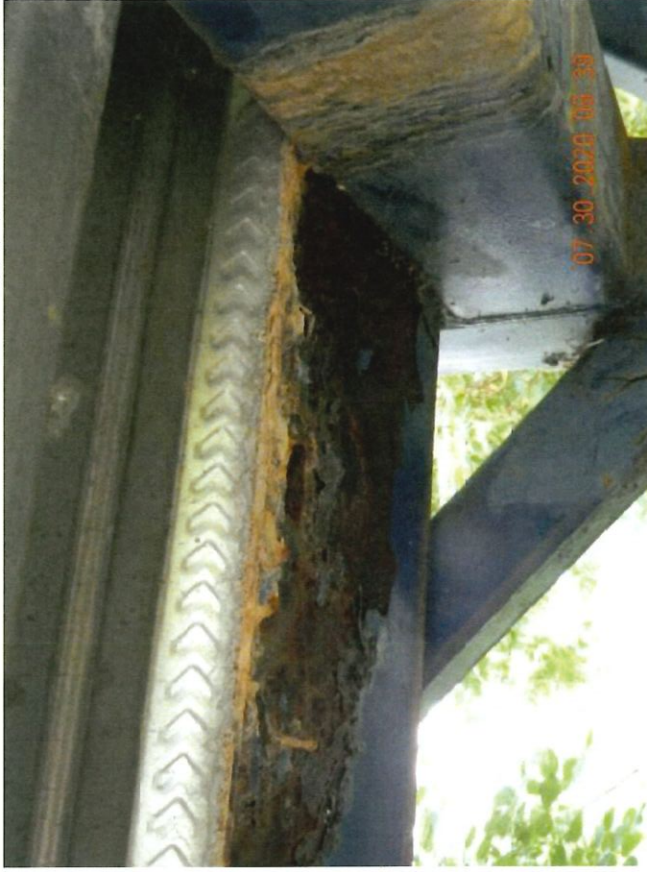
TYP. LEACHING AND RUST AT TRUSS/ DECK INTERFACE

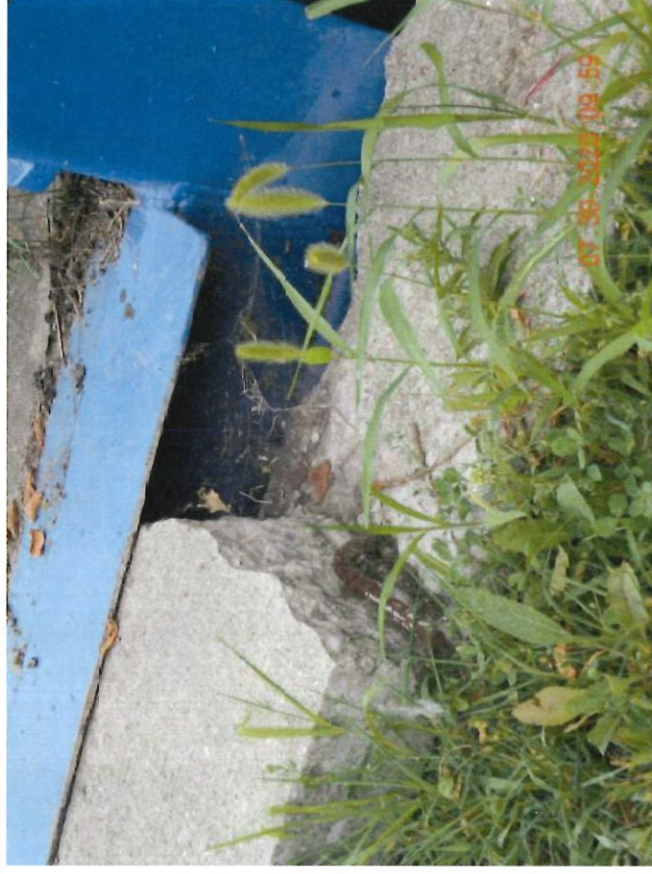
SPALL IN WEST CORNER OF NORTH END BENT MUDWALL

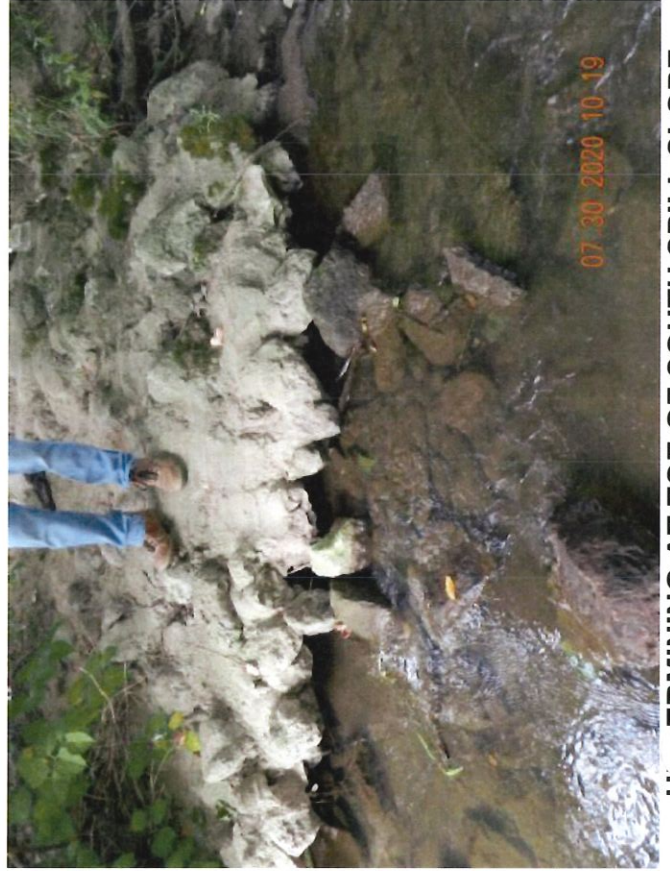
UNDERMINING AT TOE OF SOUTH SPILL SLOPE

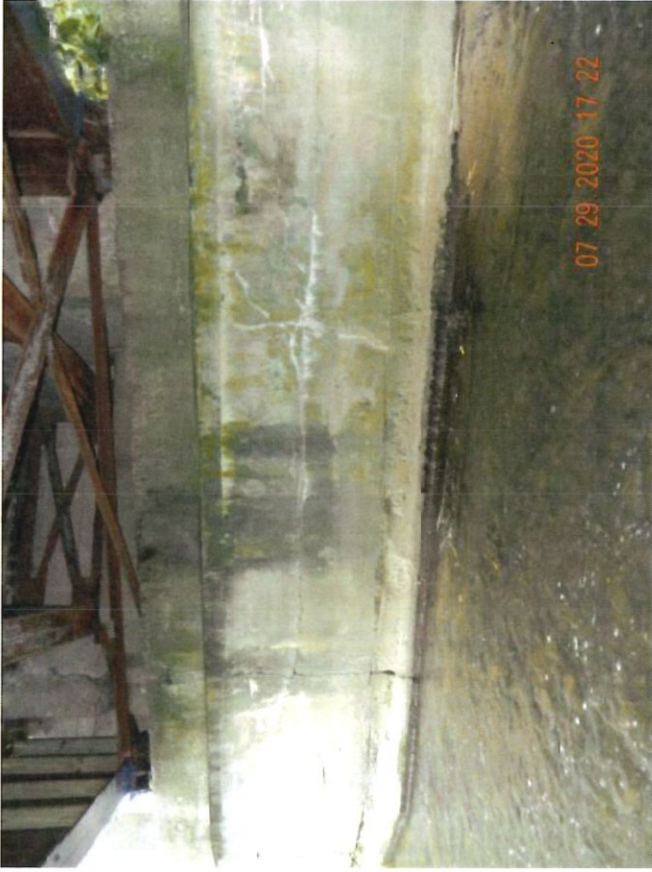
CRACKING AND SCALING IN WEST ABUTMENT

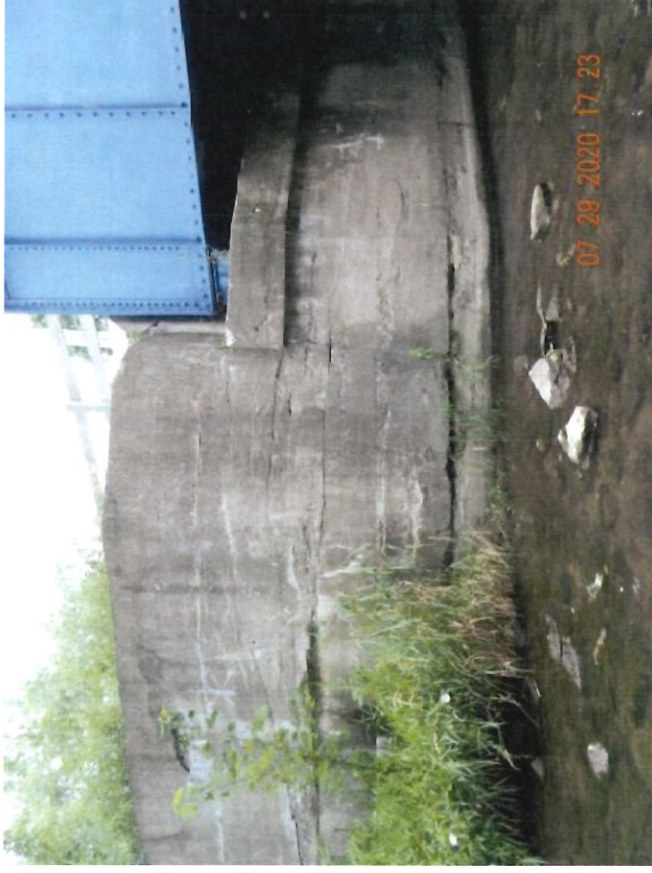
SCALING AND ABRASION IN EAST ABUTMENT

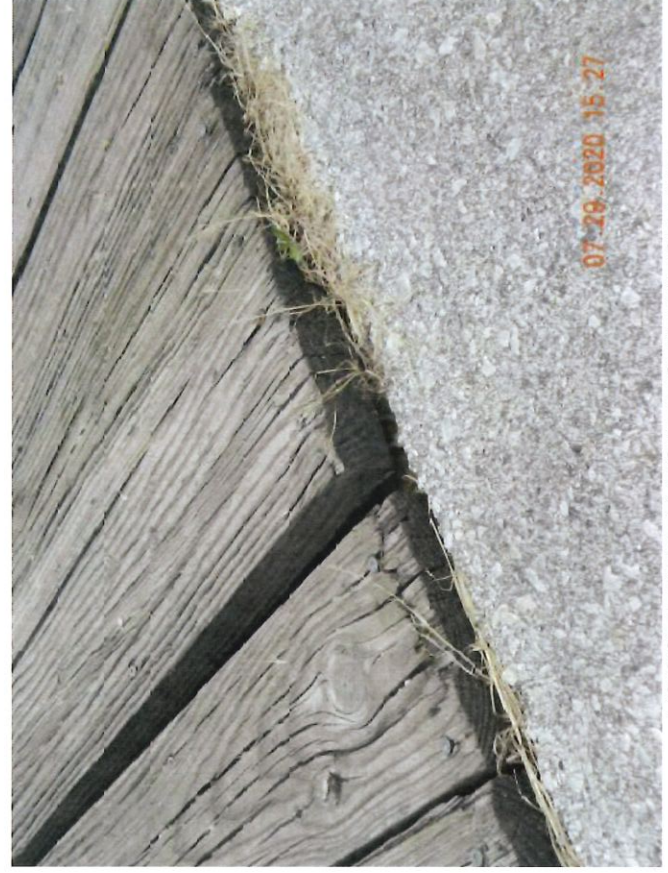
LOOSE TIMBER BOARDS AT WEST END

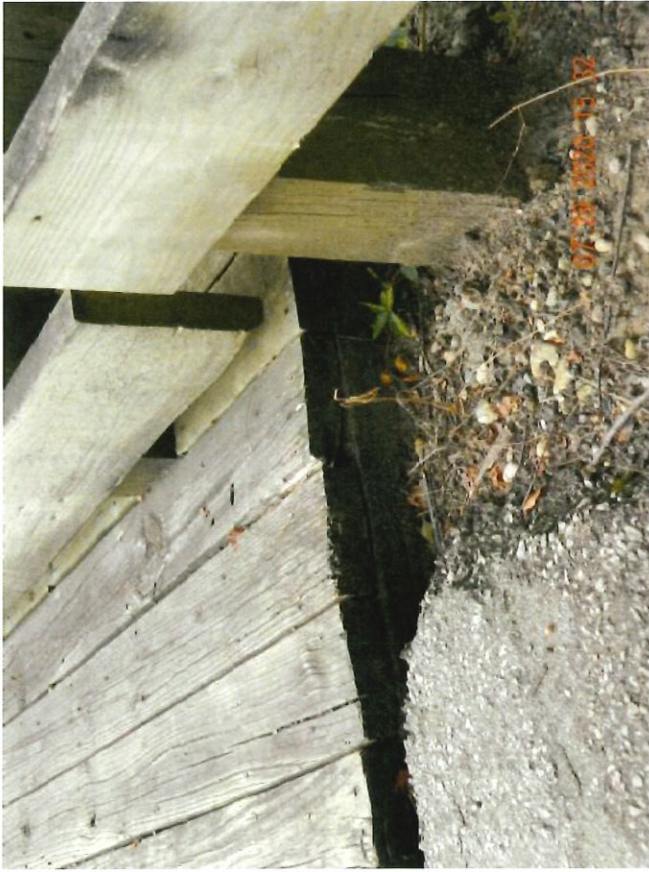
EROSION BEHIND SOUTHWEST CORNER

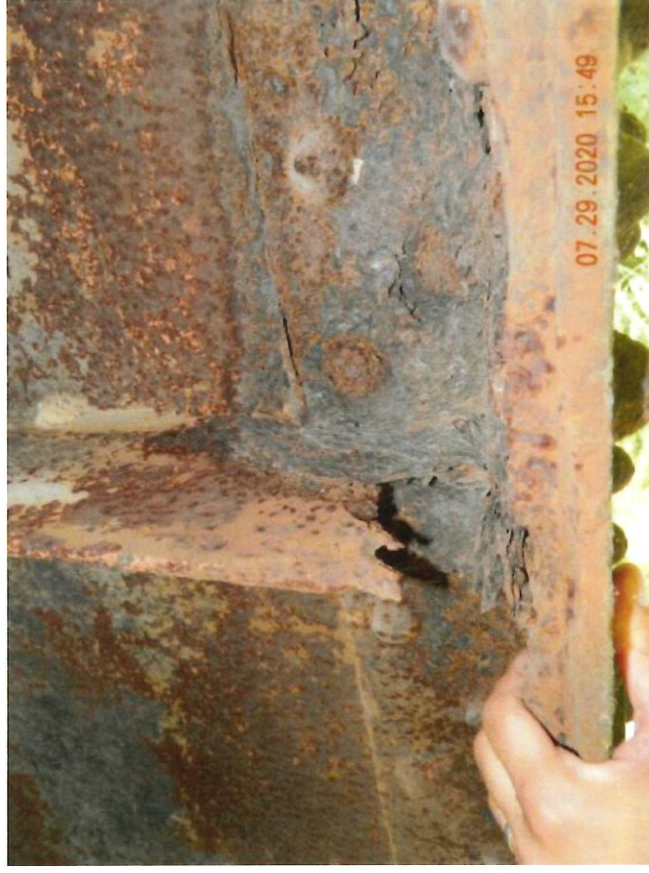
HEAVY PACK RUST AND PITTING AT STEEL STIFFENERS

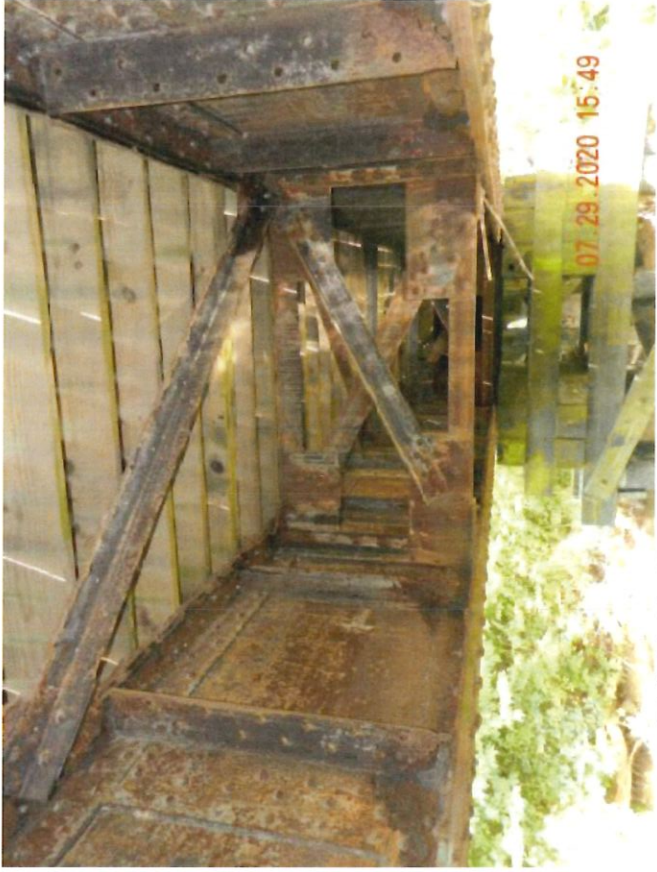
TYPICAL UNDERSIDE OF MAIN SPAN

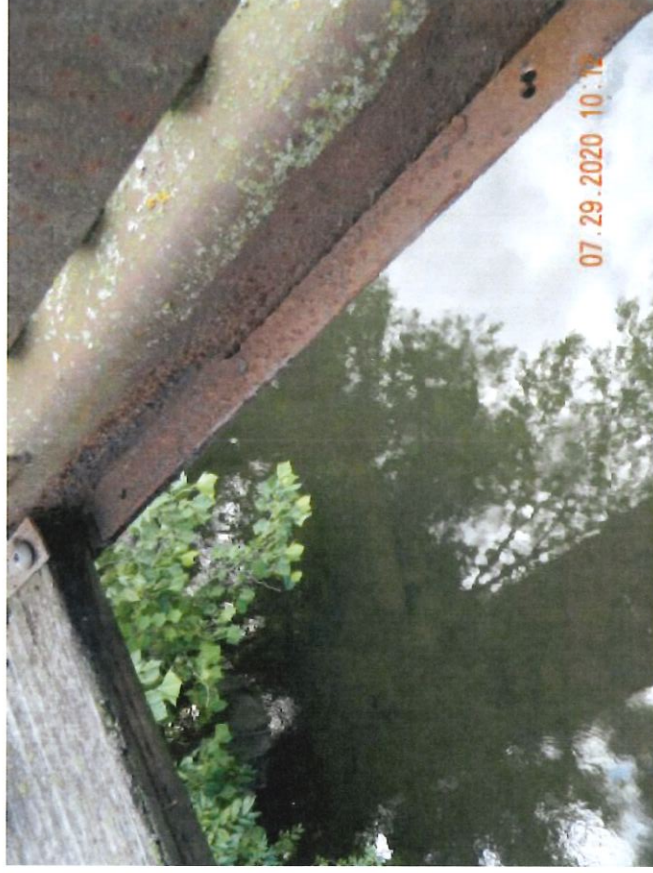
RUST AND PITTING AT LOWER CHORDS NEXT TO BOARDS

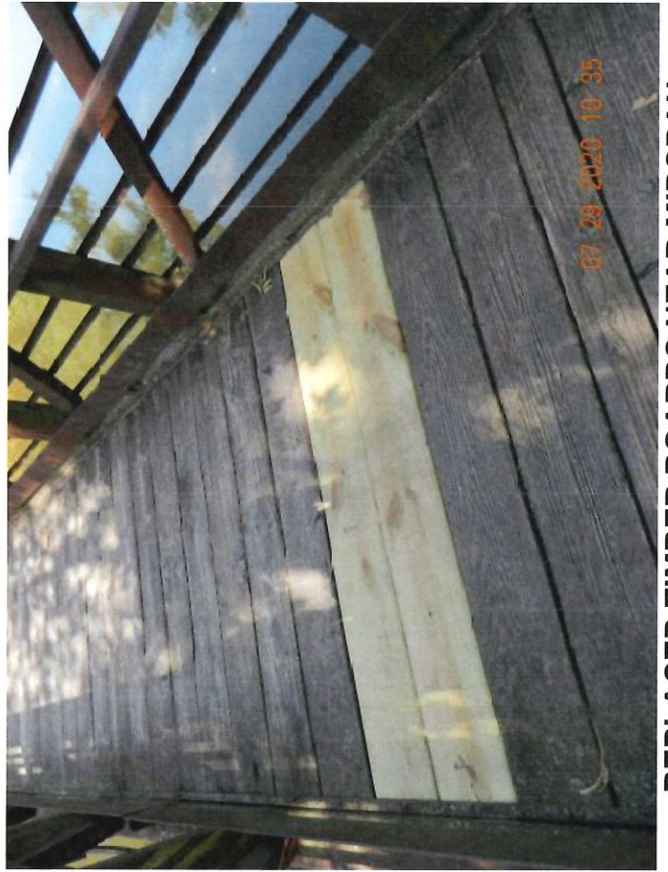
REPLACED TIMBER BOARDS NEAR MIDSPAN

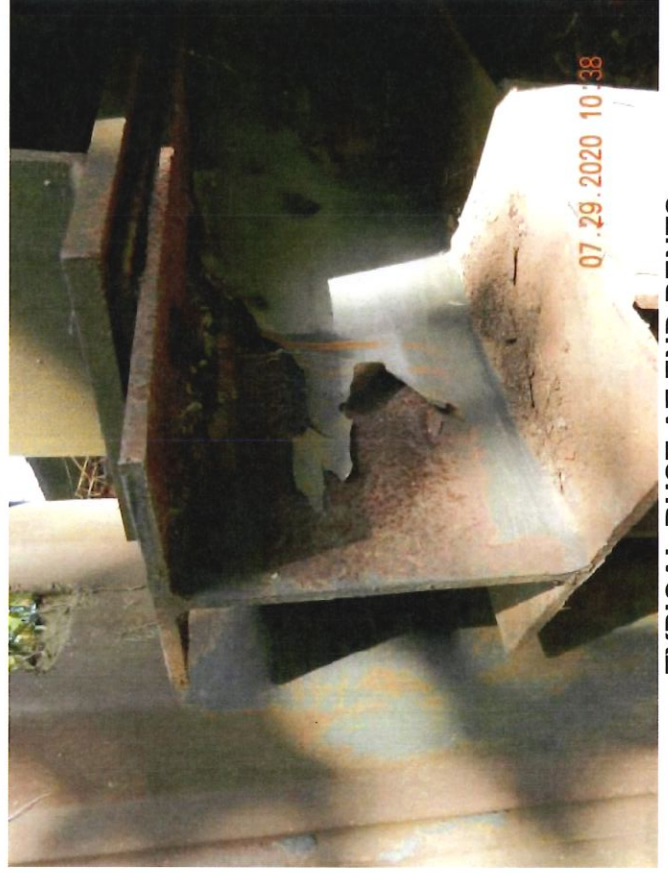
TYPICAL RUST AT END BENTS

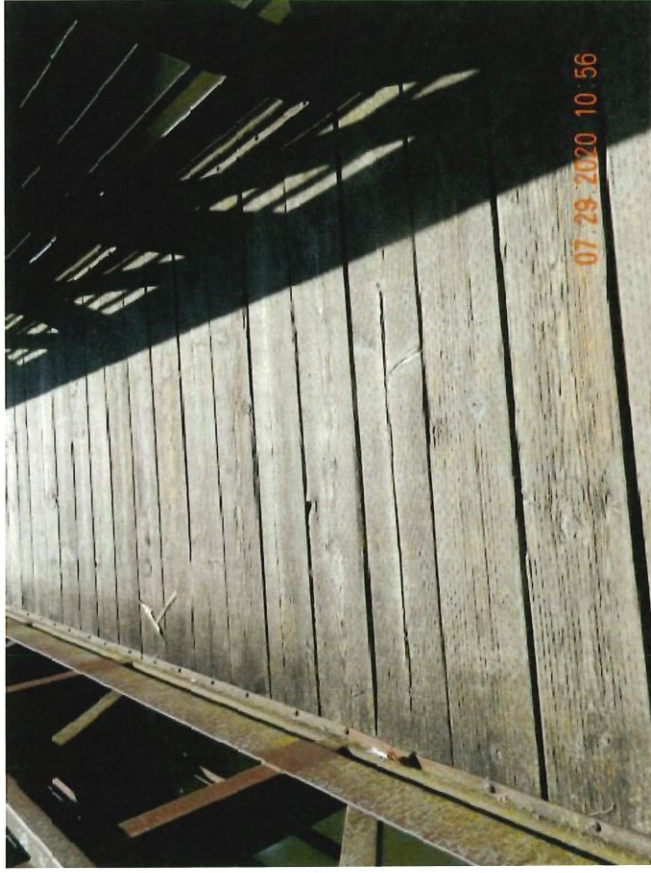
TYPICAL SPLITS & CHECKS IN TIMBER DECK

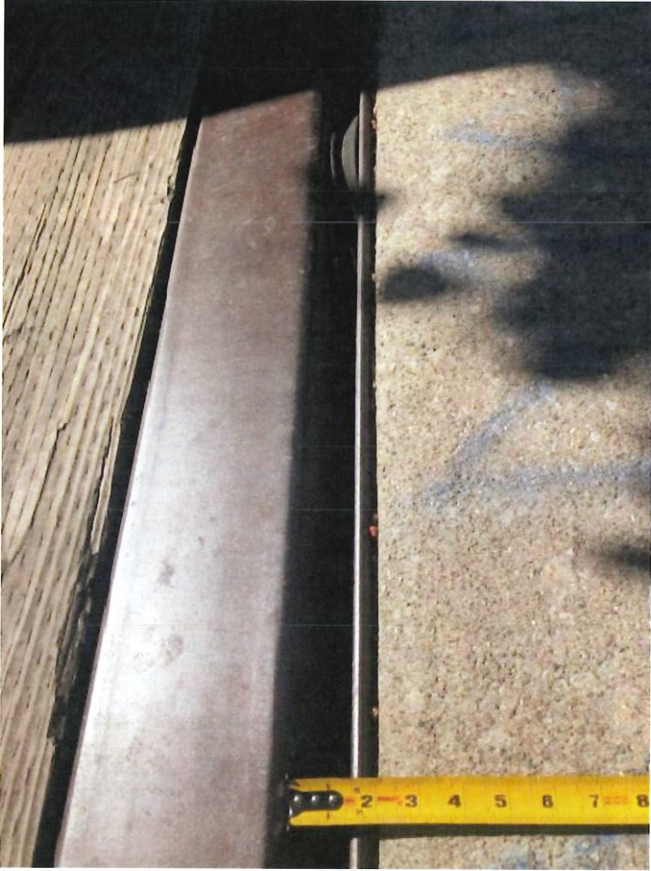
EXPANSION JOINT AT WEST END MISSING MATERIAL

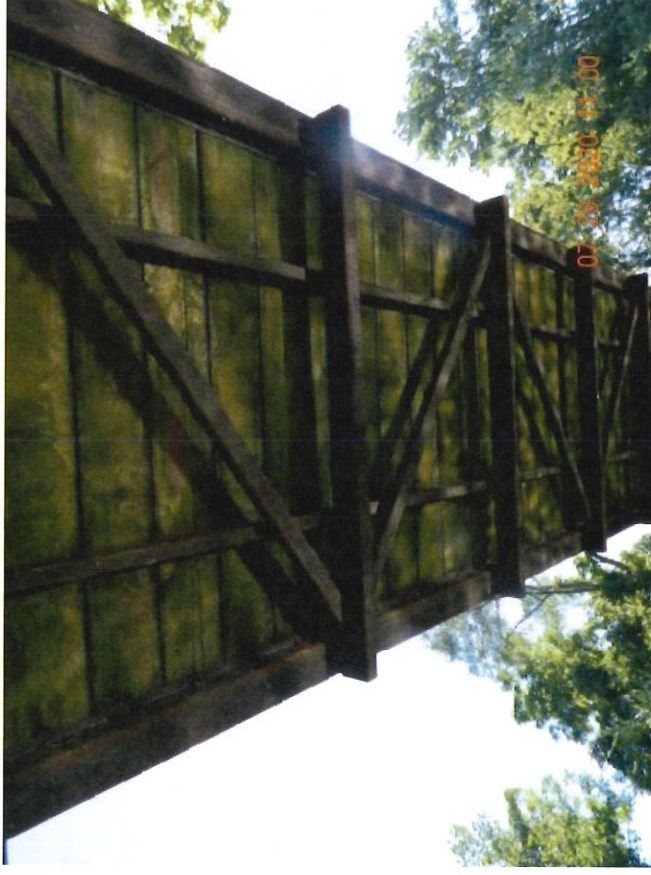
TYPICAL UNDERSIDE OF STRUCTURE

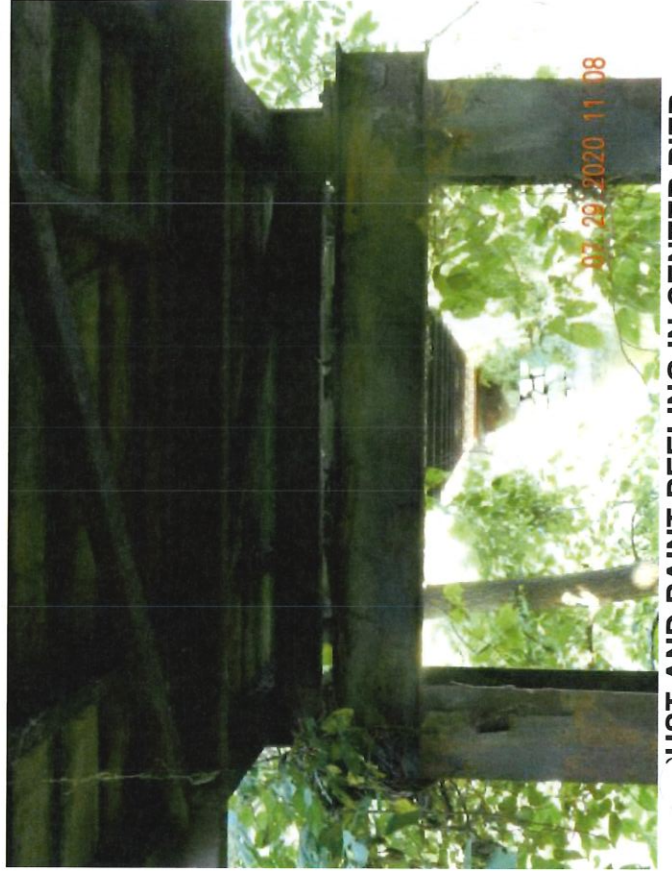
RUST AND PAINT PEELING IN CENTER PIER

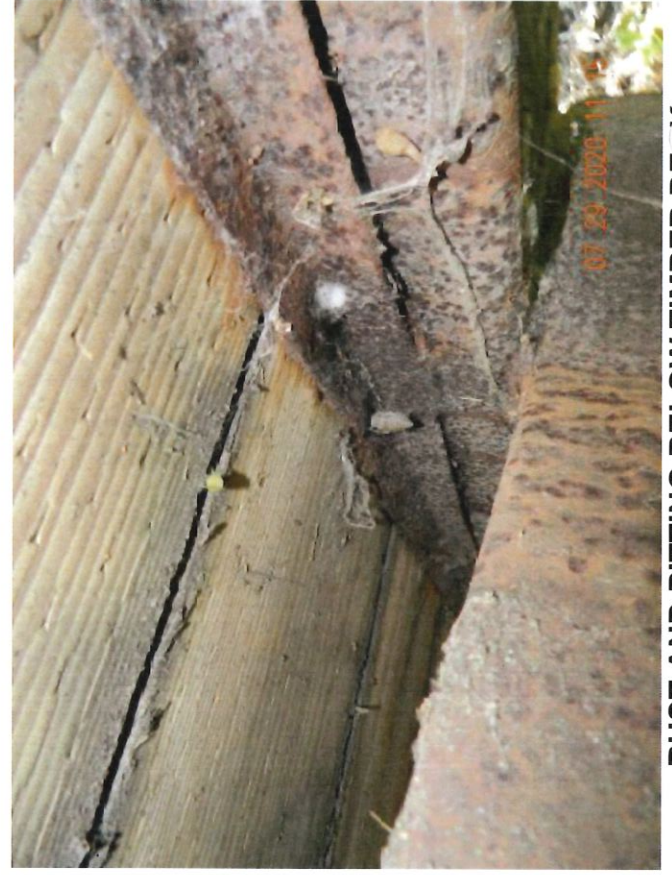
RUST AND PITTING BELOW TIMBER DECK

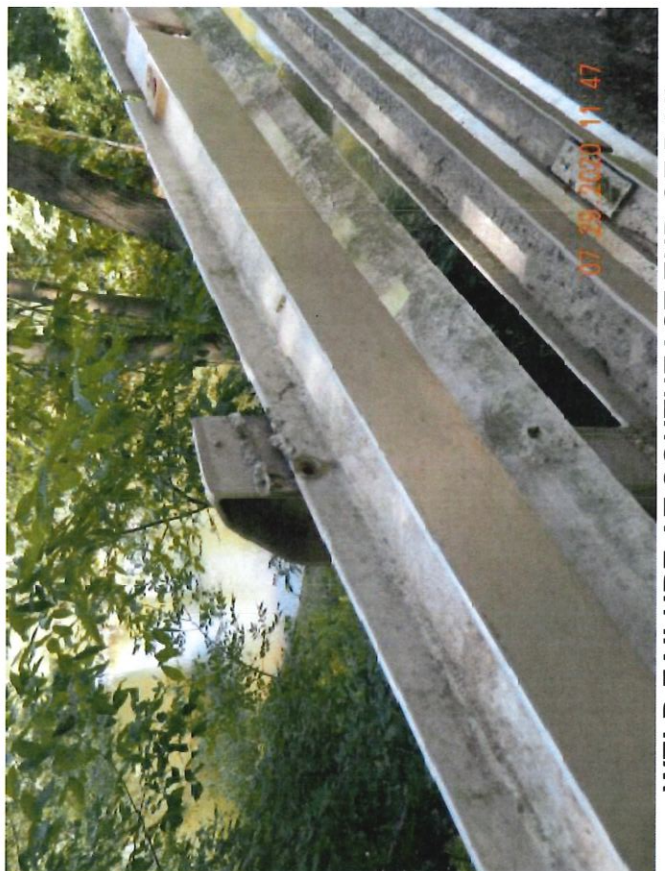
WELD FAILURE AT SOUTHEAST END OF RAIL

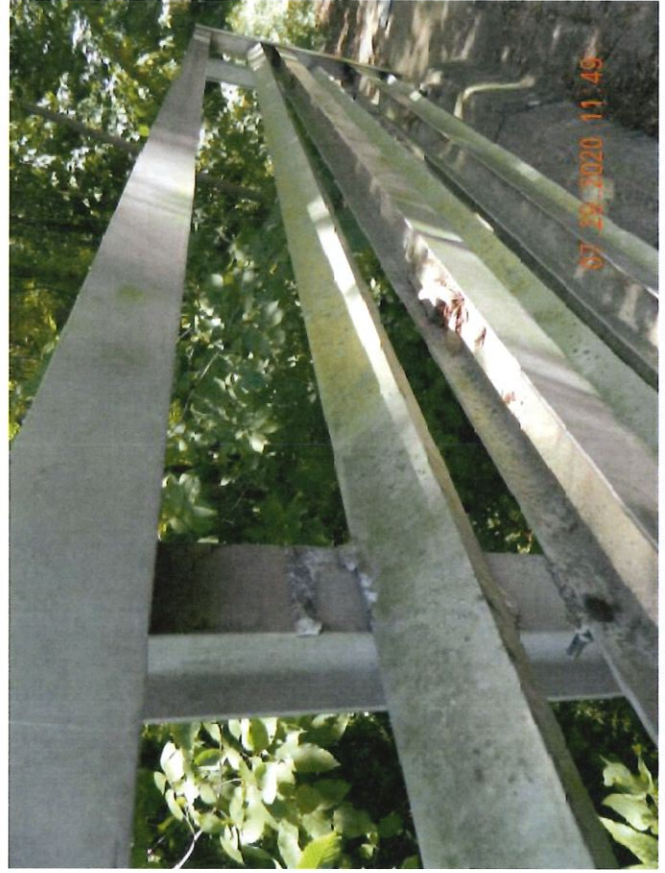
WELD FAILURE AT NORTHEAST END OF RAIL

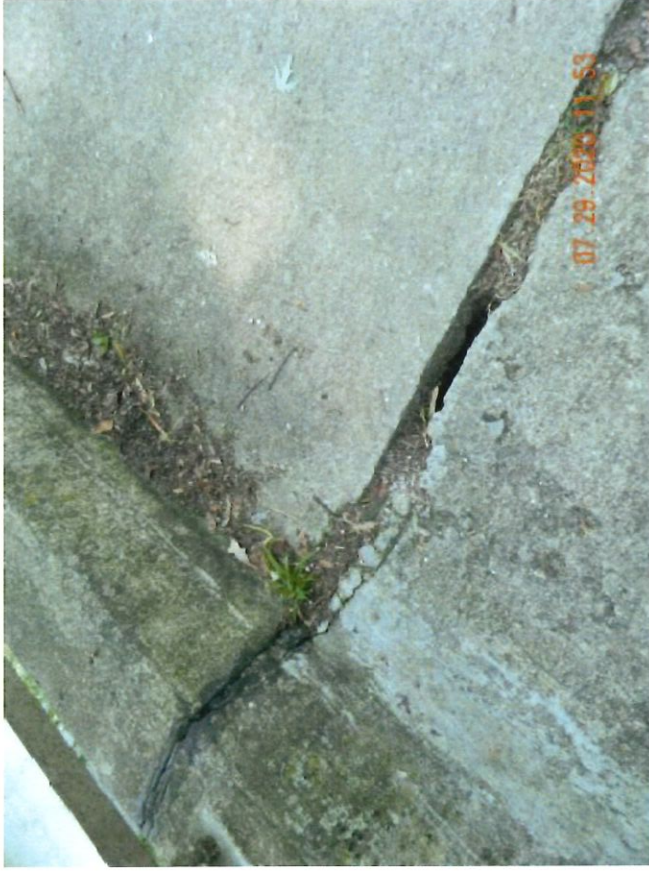
FAILED EAST EXPANSION JOINT DECK

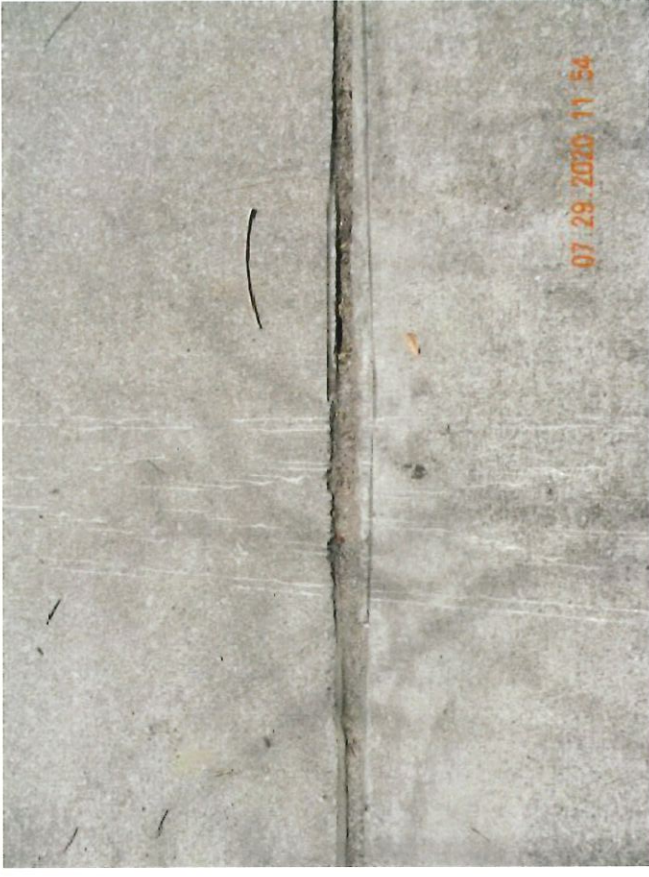
FAILED WEST EXPANSION JOINT DECK

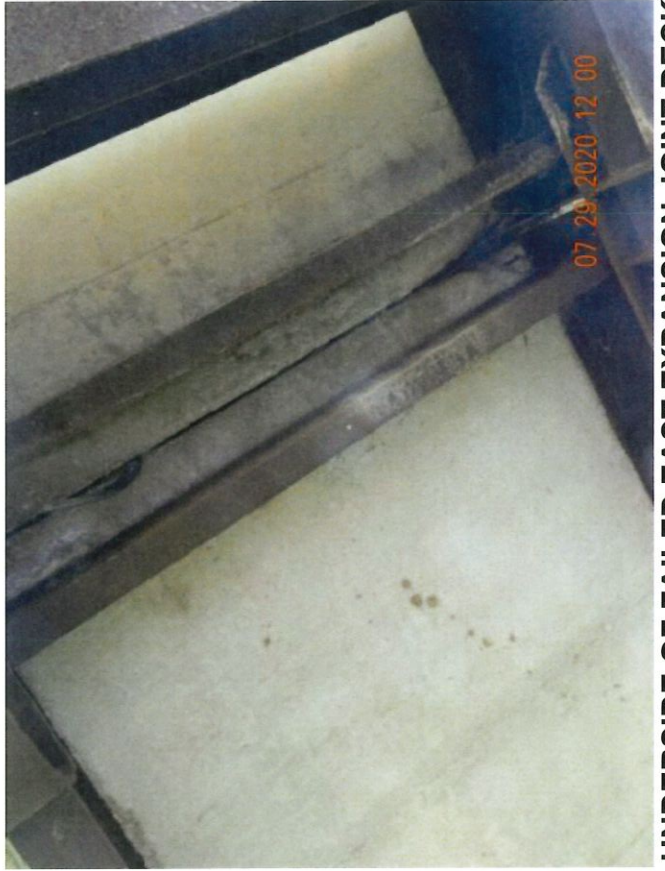
UNDERSIDE OF FAILED EAST EXPANSION JOINT DECK

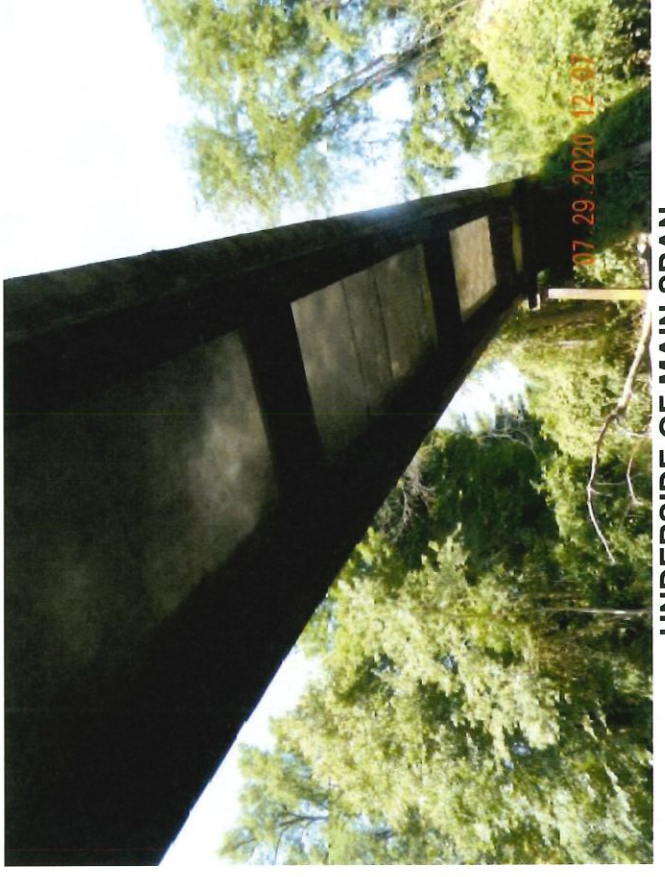
UNDERSIDE OF MAIN SPAN

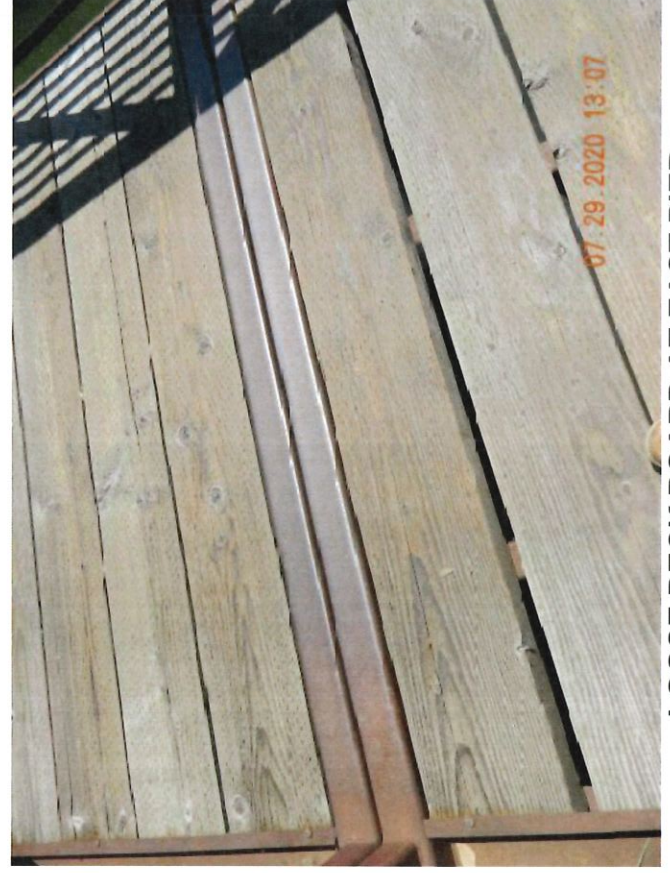
LOOSE DECK BOARD AT EAST PIER

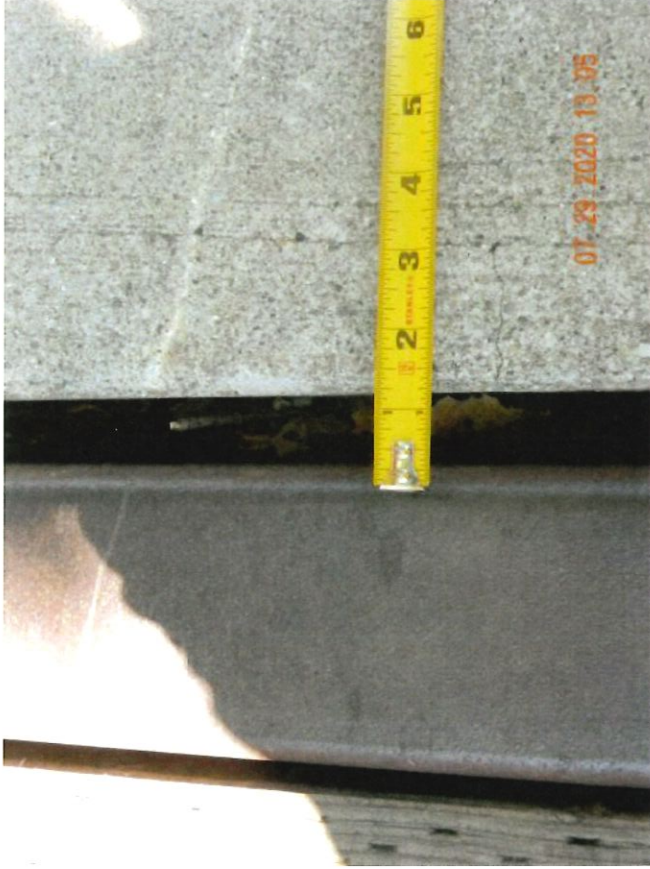
>1" SEPARATION AT EAST APPROACH END

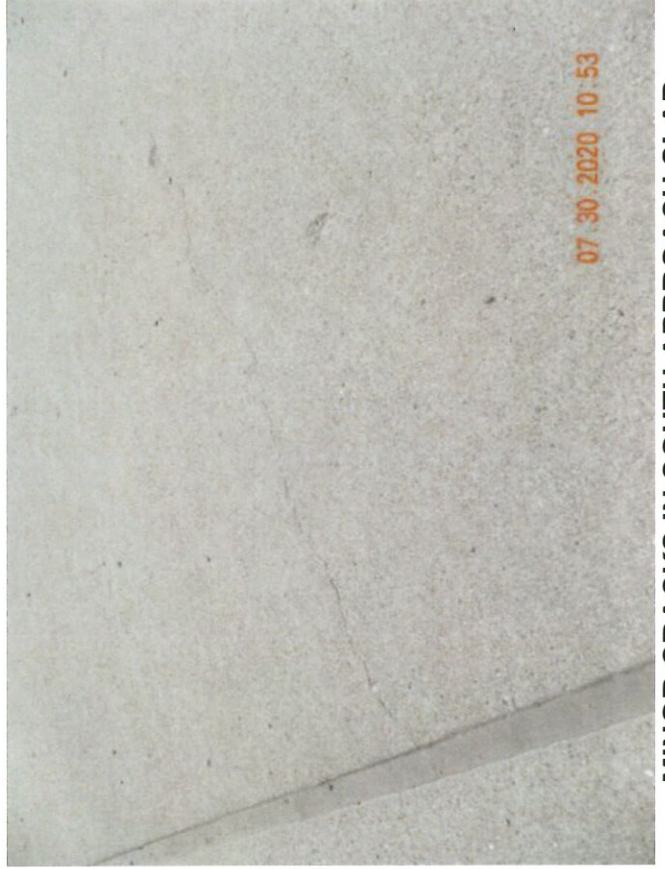
MINOR CRACKS IN SOUTH APPROACH SLAB

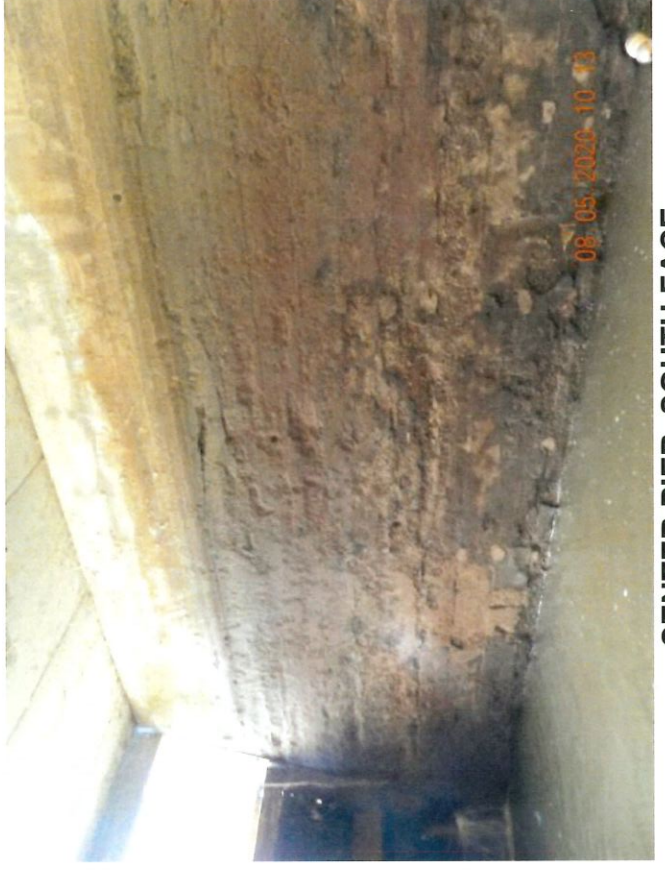
CENTER PIER, SOUTH FACE

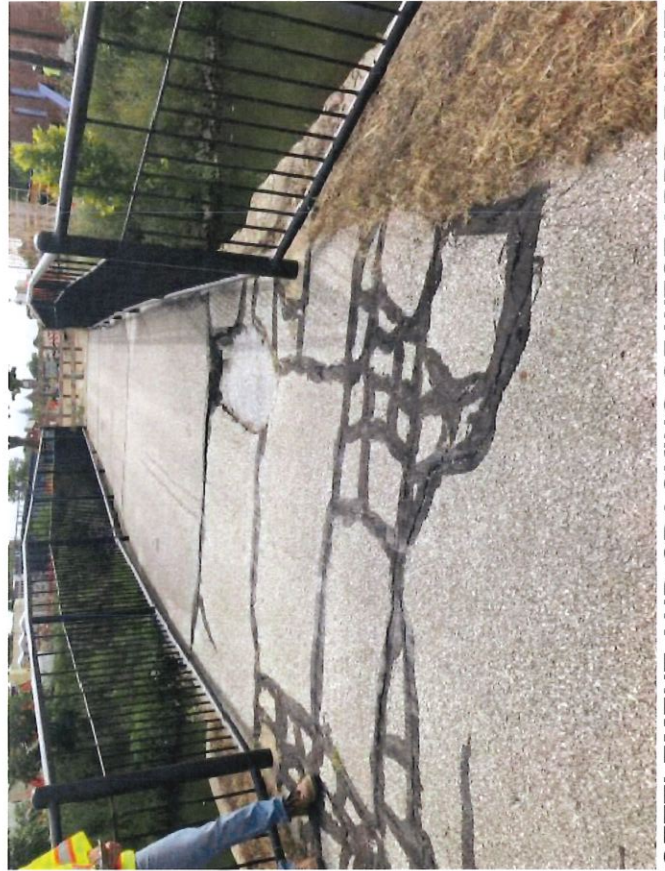
SETTLEMENT AND CRACKING OF WEST APPR. PAVMT.

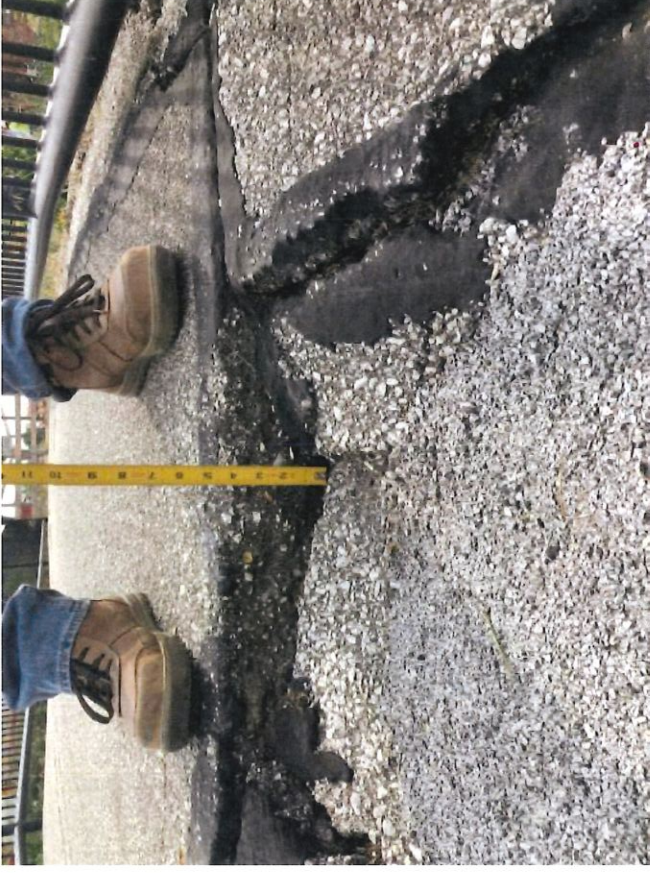
SETTLEMENT IN WEST APPROACH

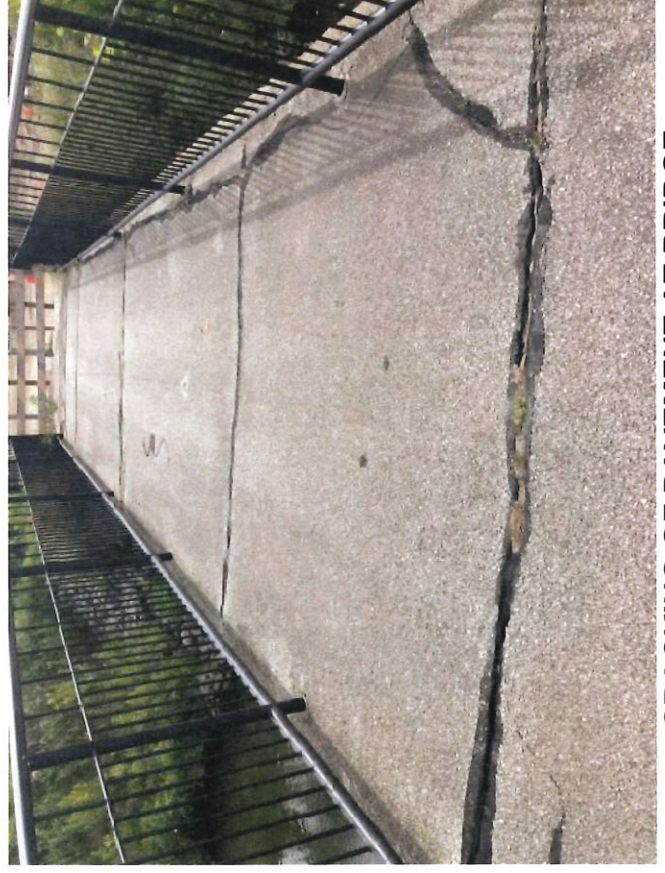
CRACKING OF PAVEMENT AT BRIDGE

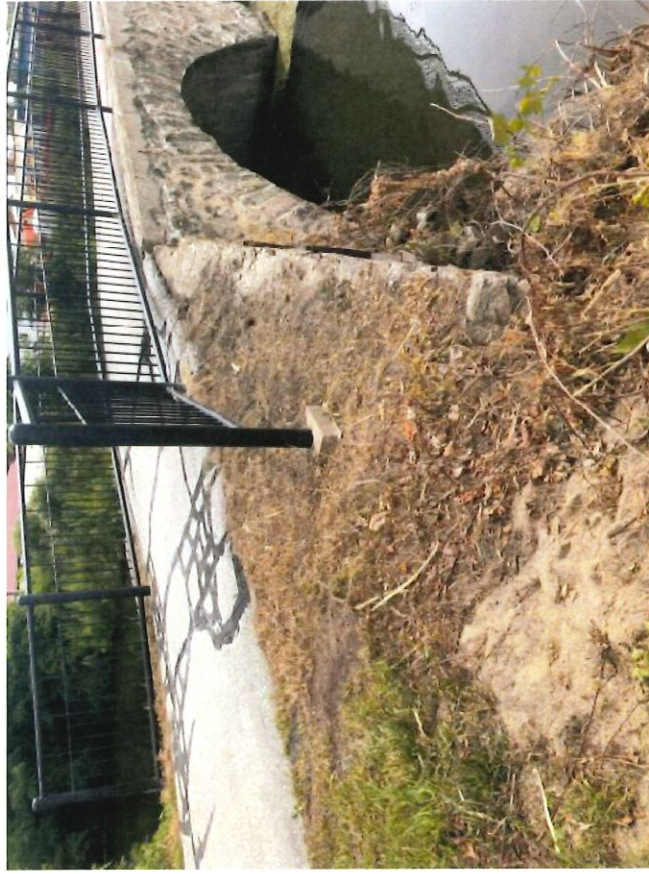
EROSION AT SOUTHWEST WINGWALL
