BRIDGE INSPECTION REPORT CITY OF GOSHEN, INDIANA

PHASE I - 2020

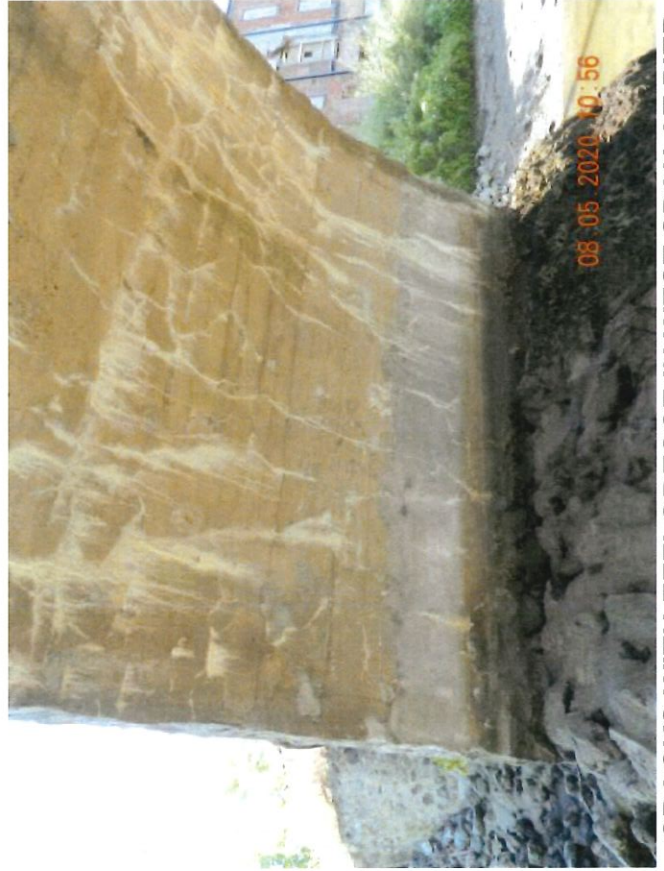
CRACKS WITH EFFLORESCE IN WEST SPAN AT PIER

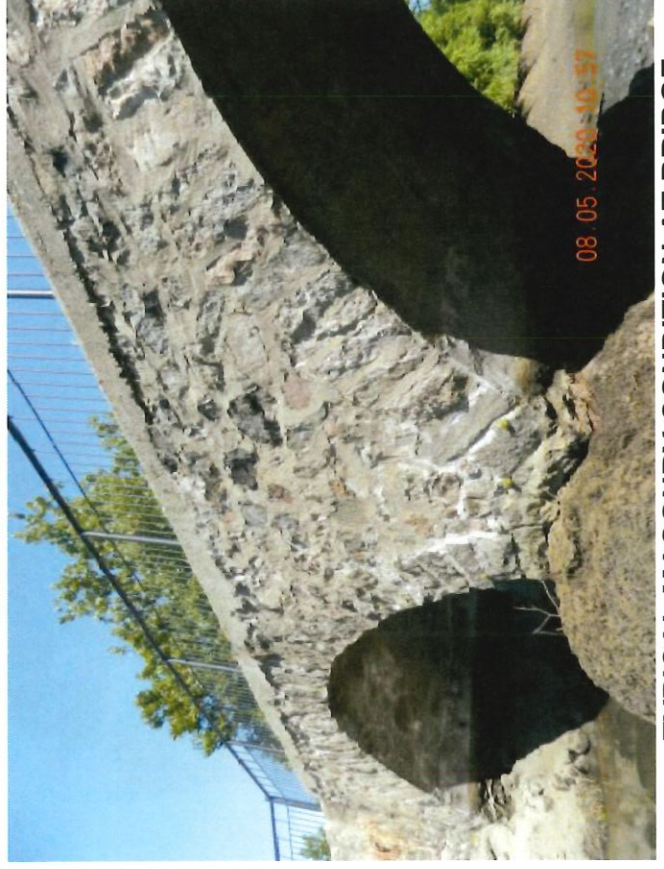
TYPICAL MASONRY CONDITION AT BRIDGE

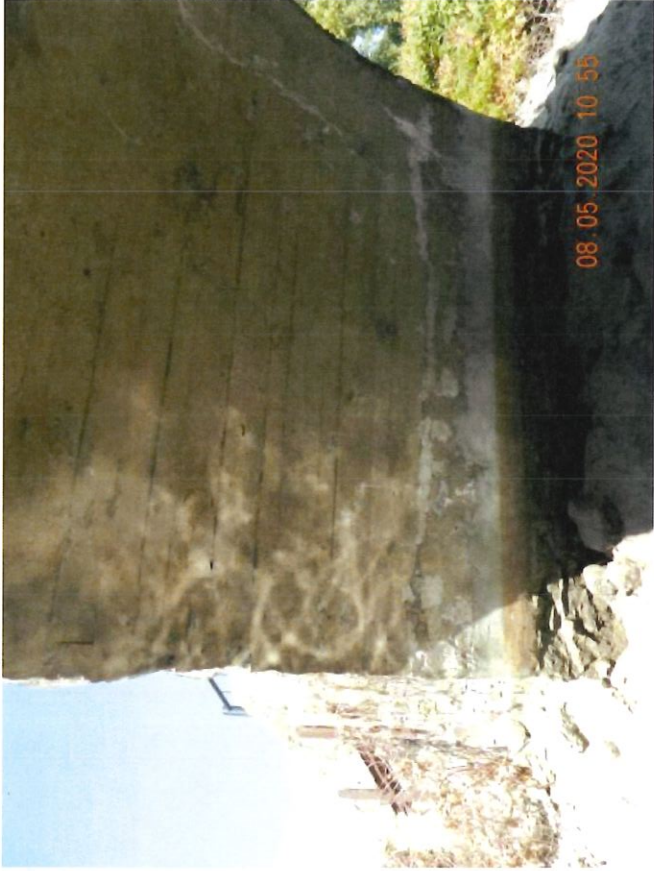
CITY OF GOSHEN BRIDGE NO. 301

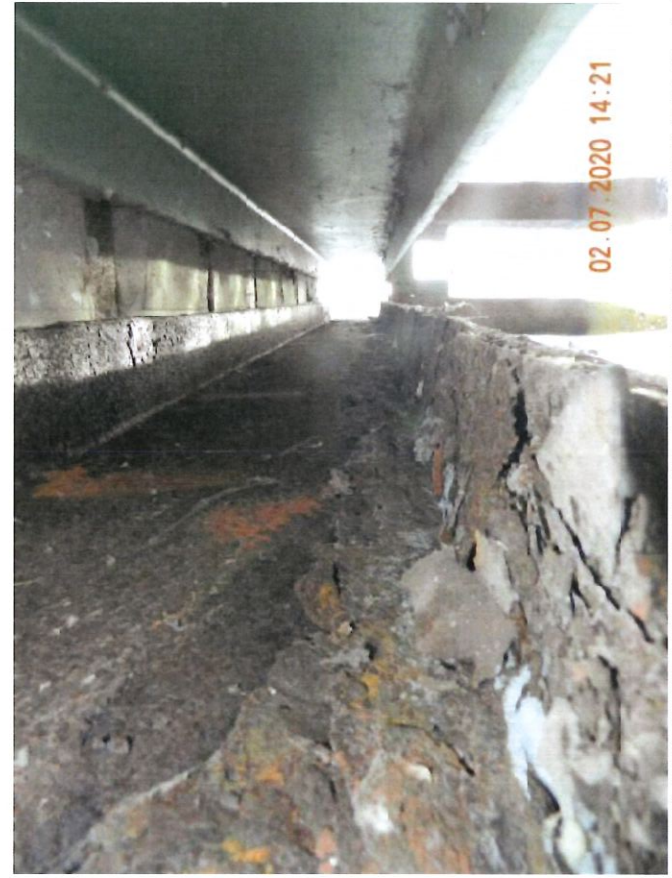
TYP. PACK RUST IN ORIGINAL BENT CAPS AT BENTS 3, 4 & 5

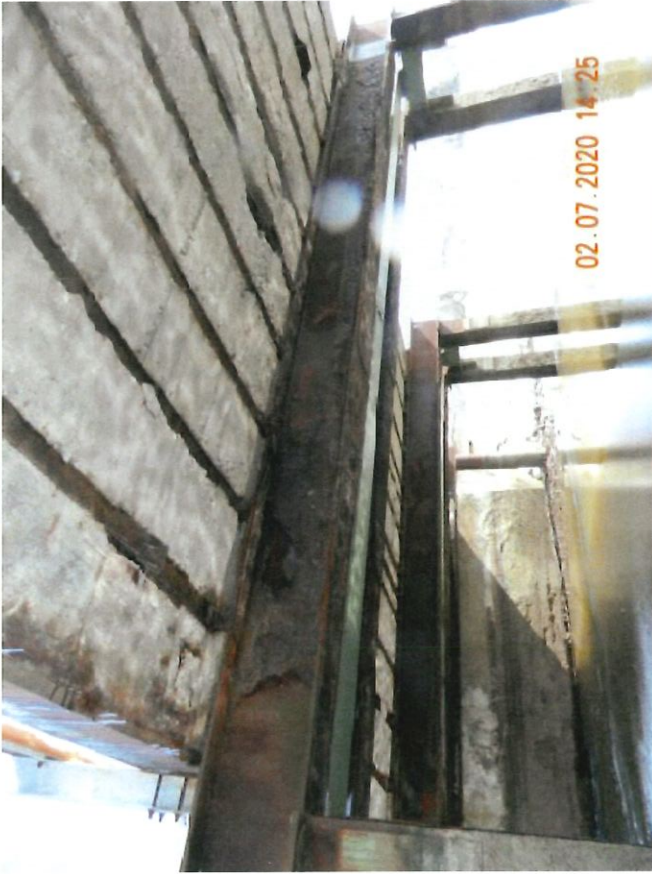
WEST BENT CAP BEAM AT BENT 4

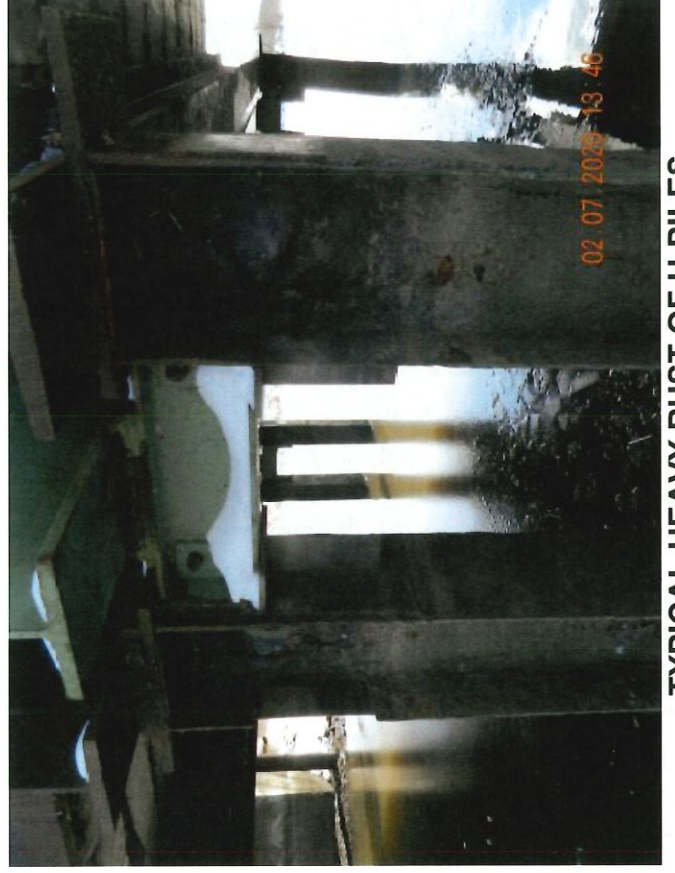
TYPICAL HEAVY RUST OF H-PILES

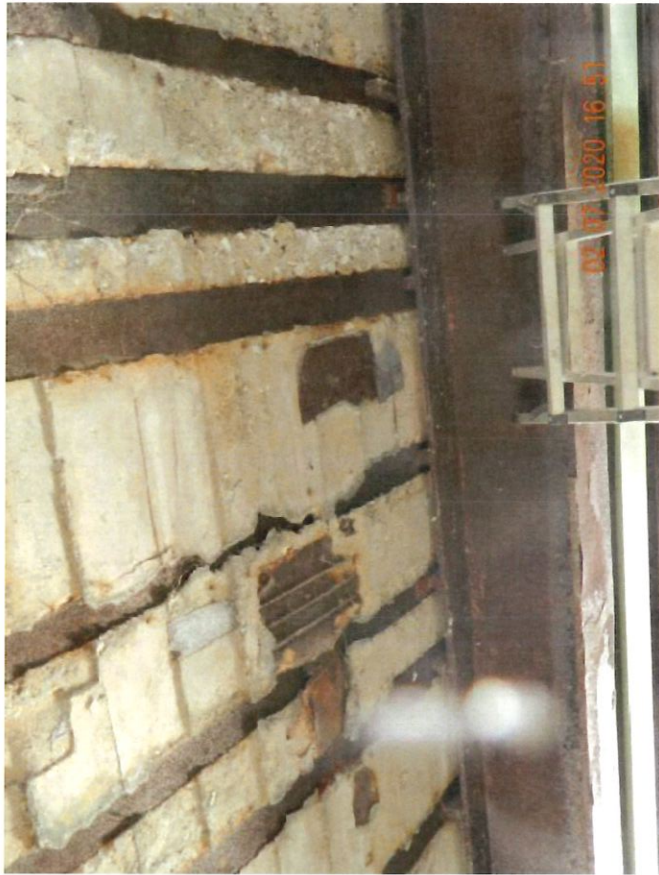
UNDERSIDE OF EAST SPAN

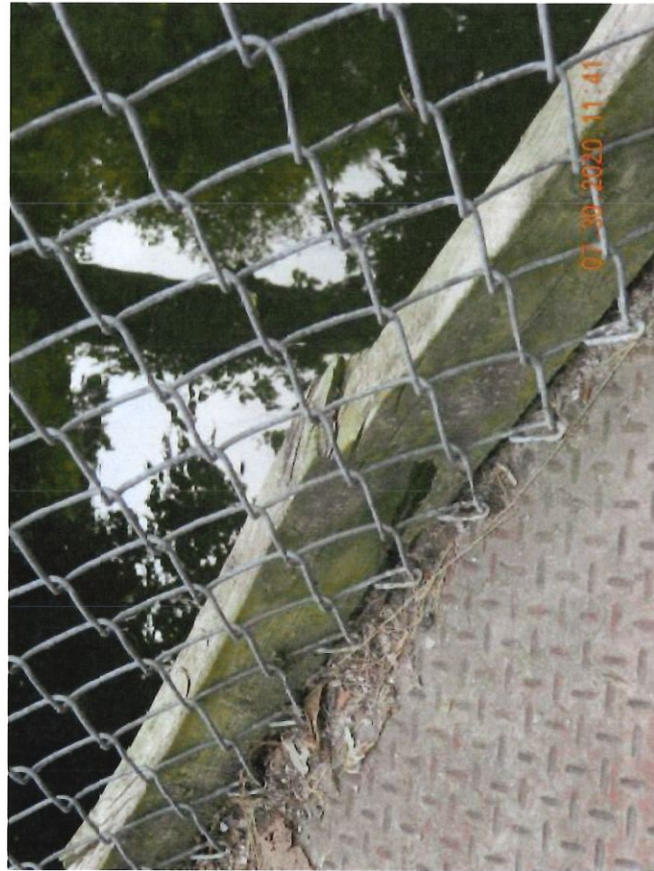
DAMAGED KICKBOARD IN SOUTH RAIL NEAR MIDSPAN

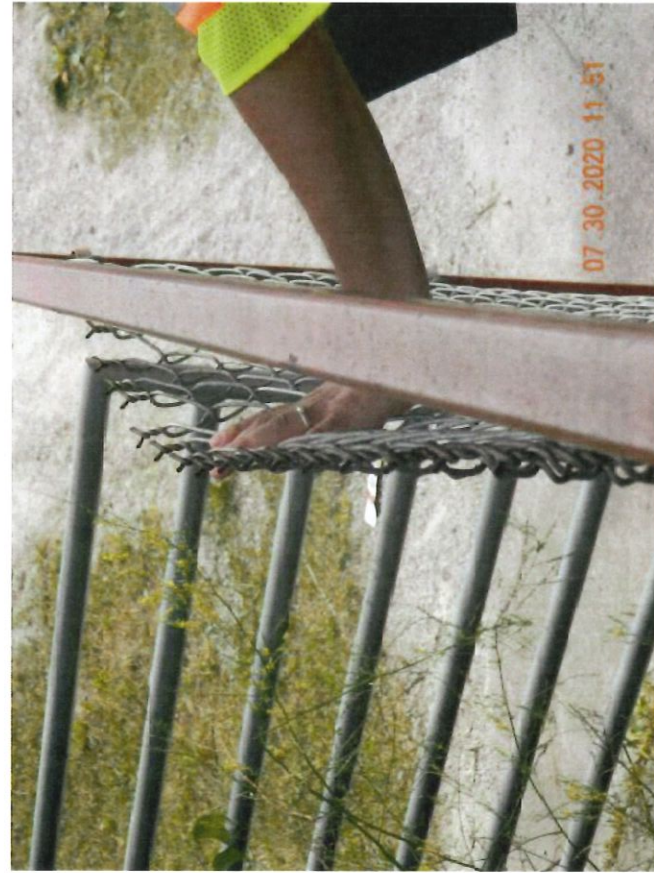
LOOSE FENCE IN NORTH RAIL AT EAST END

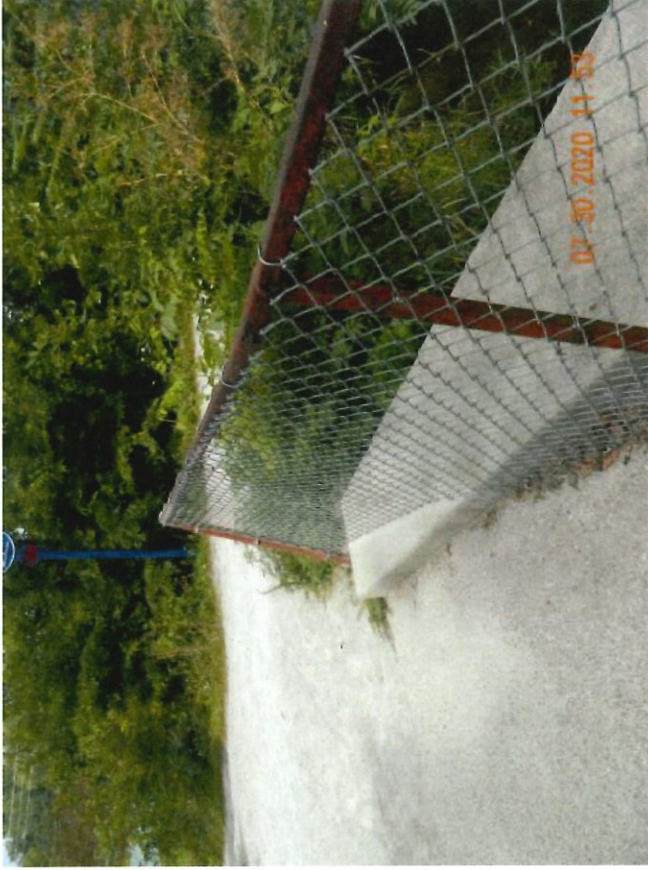
NORTH RAIL BENT AT WEST END

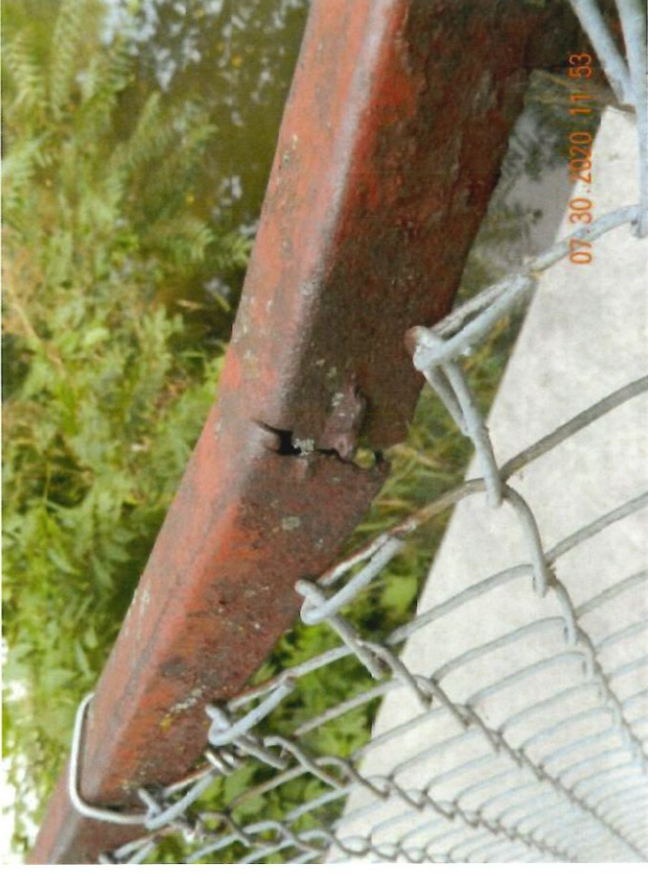
BROKEN TOP BAR IN BENT RAIL AT WEST END

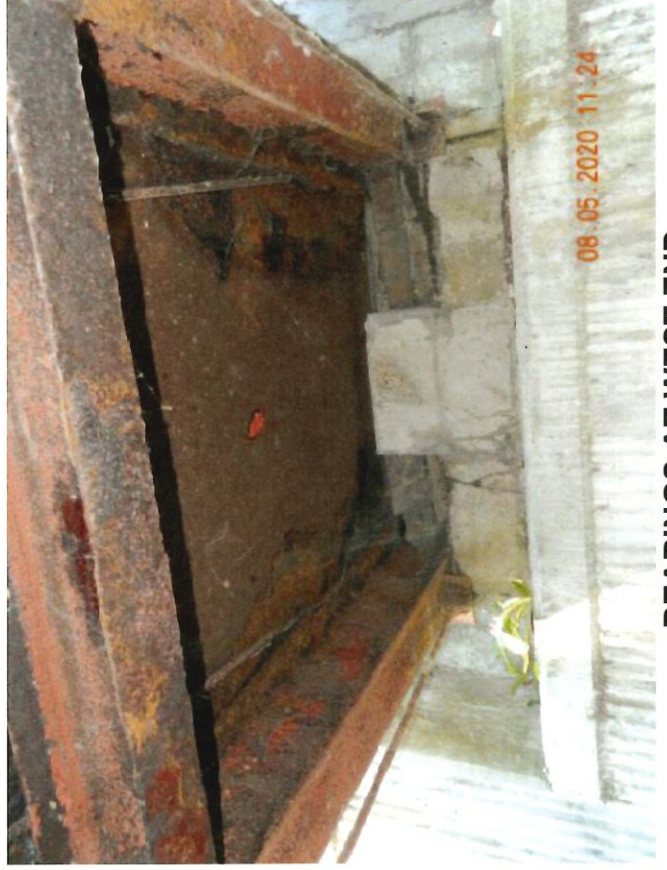
BEARINGS AT WEST END

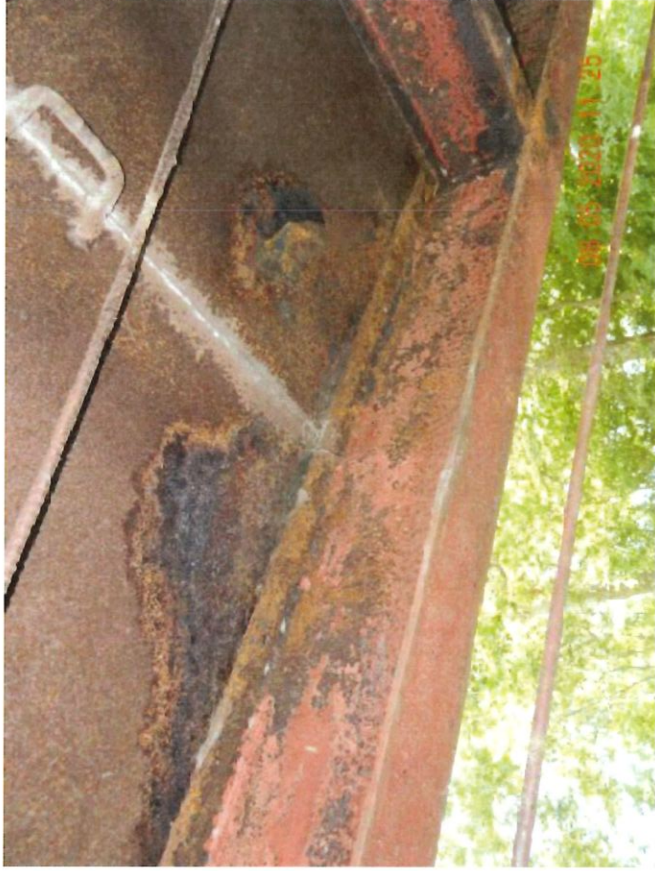
TYPICAL RUST & PITTING OF STEEL BEAMS AND DECK PL

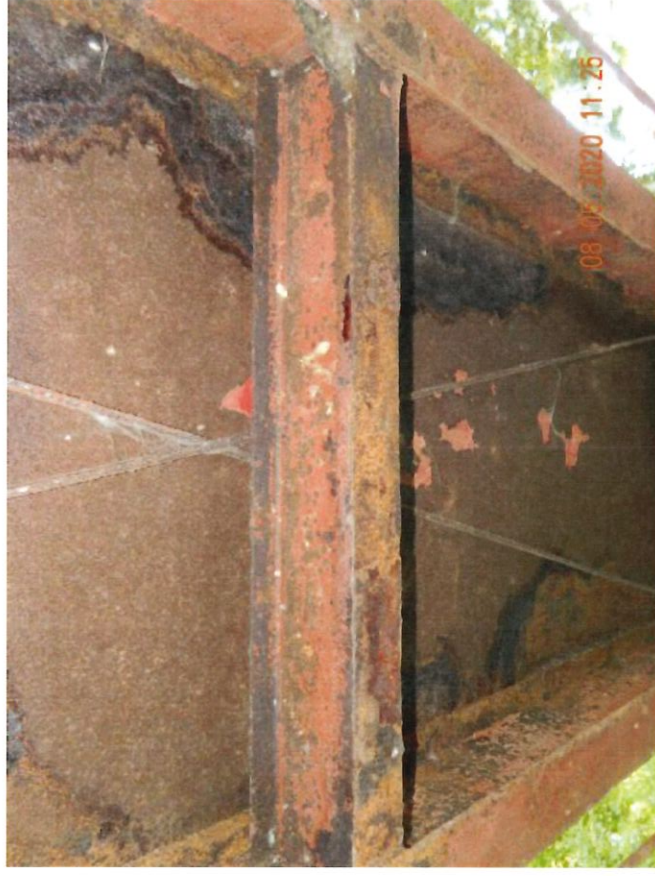
HEAVY RUST IN STEEL DIAPHRAGM

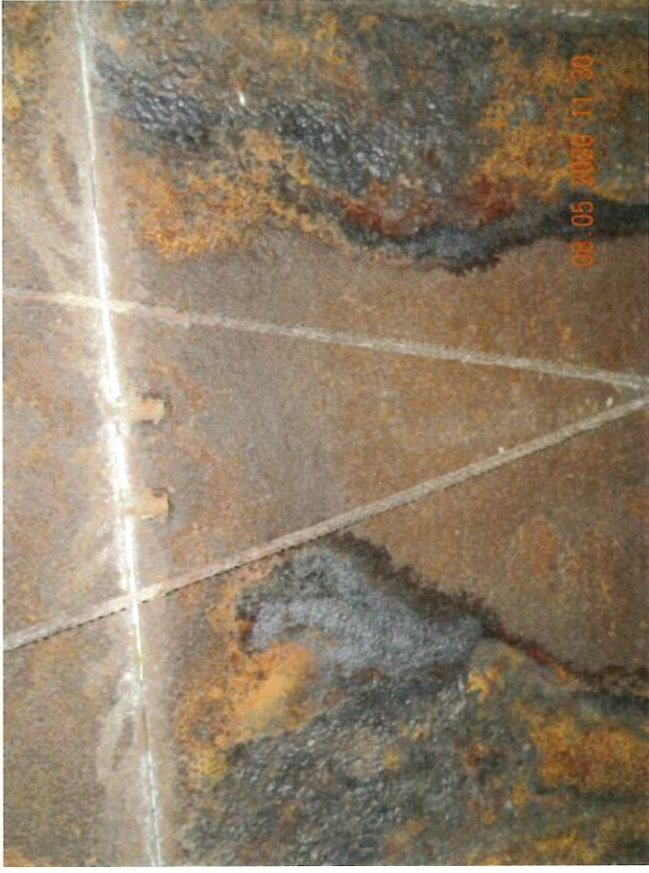
RUST AND SEPARATION OF DECK PL NEAR MIDSPAN

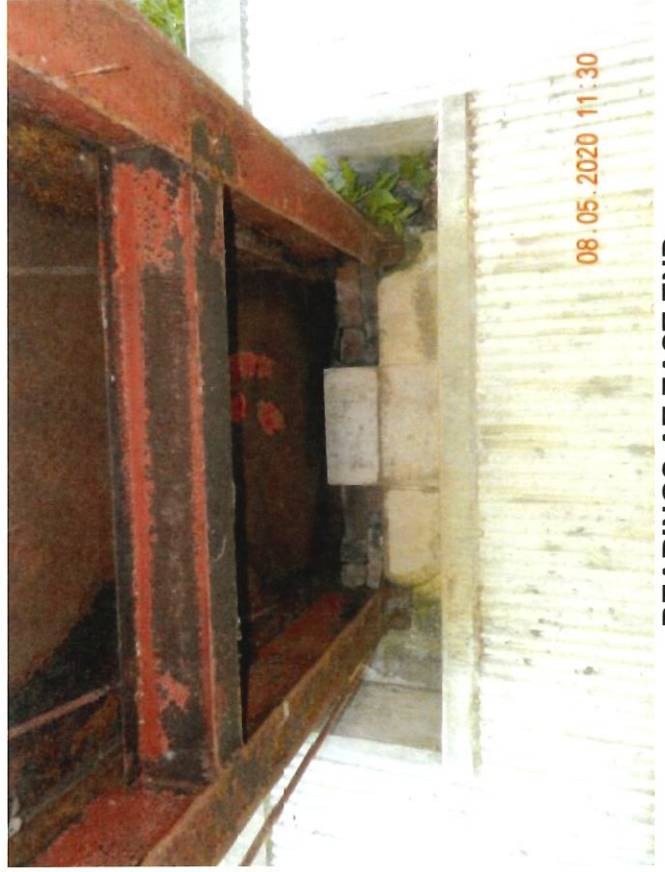
BEARINGS AT EAST END

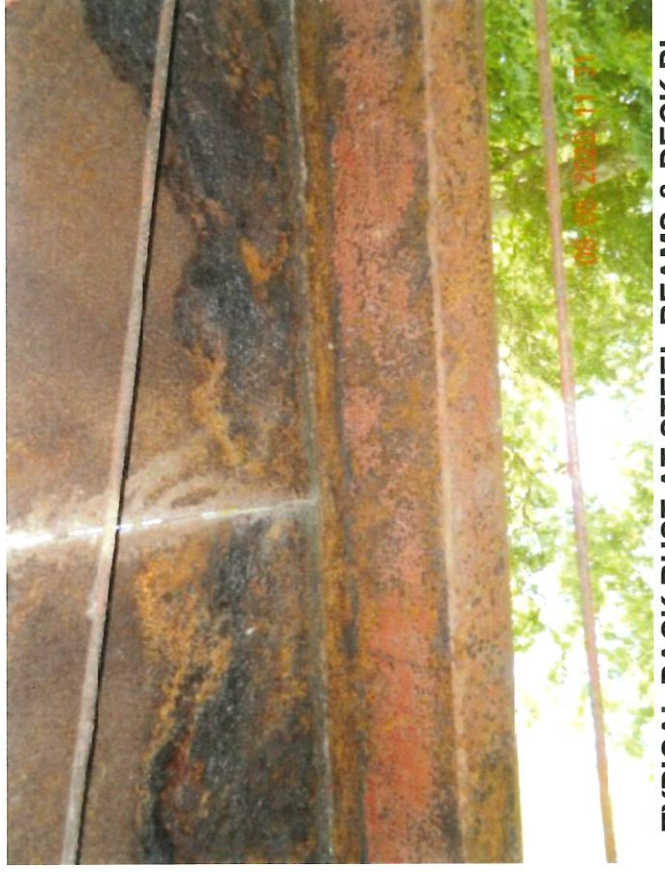
TYPICAL PACK RUST AT STEEL BEAMS & DECK PL

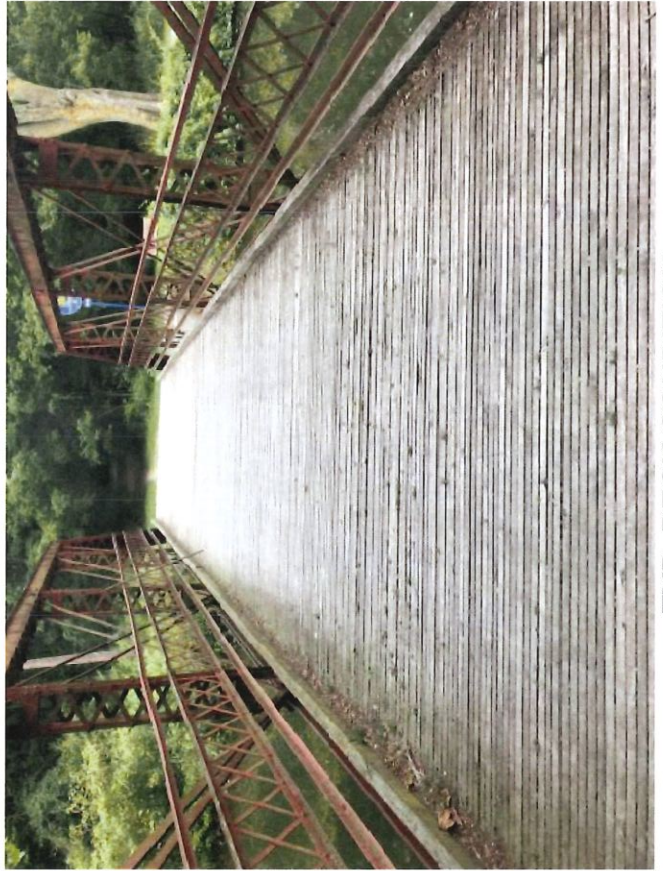
TYP. SPLITTING OF TIMBER CURBS

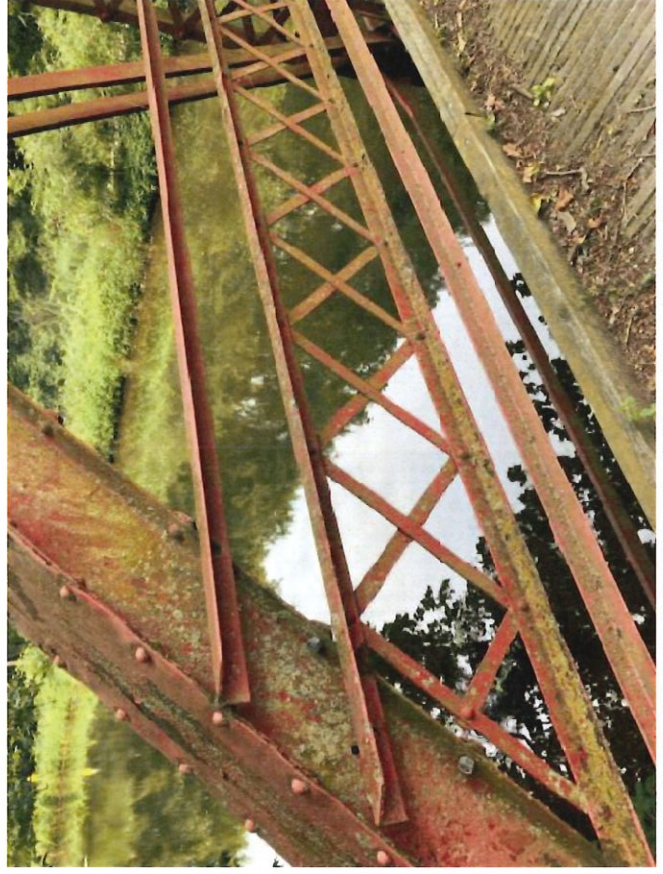
MOISTURE AND RUST IN SOUTH TRUSS AT E ^ ST END

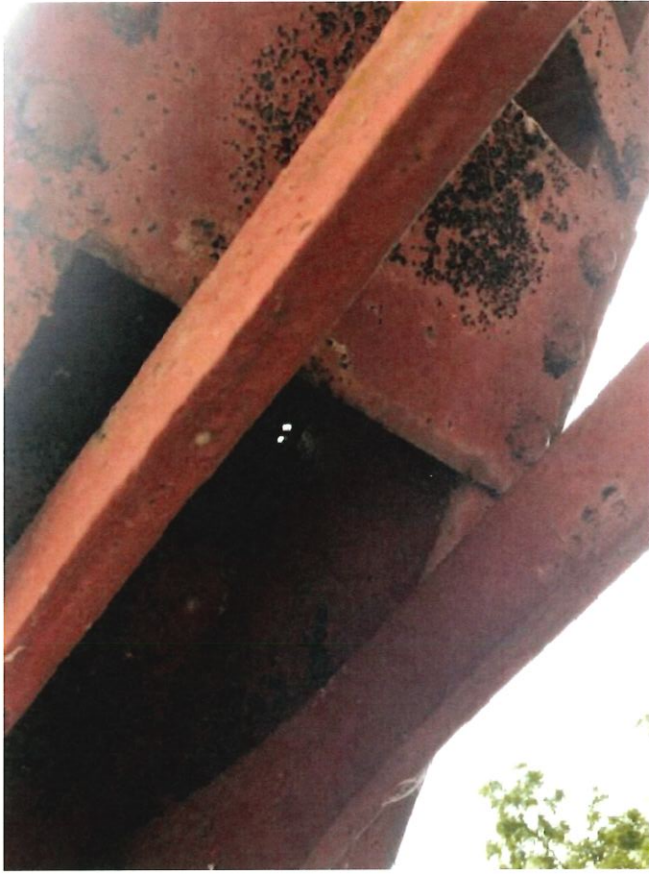
PITTING AND MINOR SECTION LOSS AT UPPER CHORD

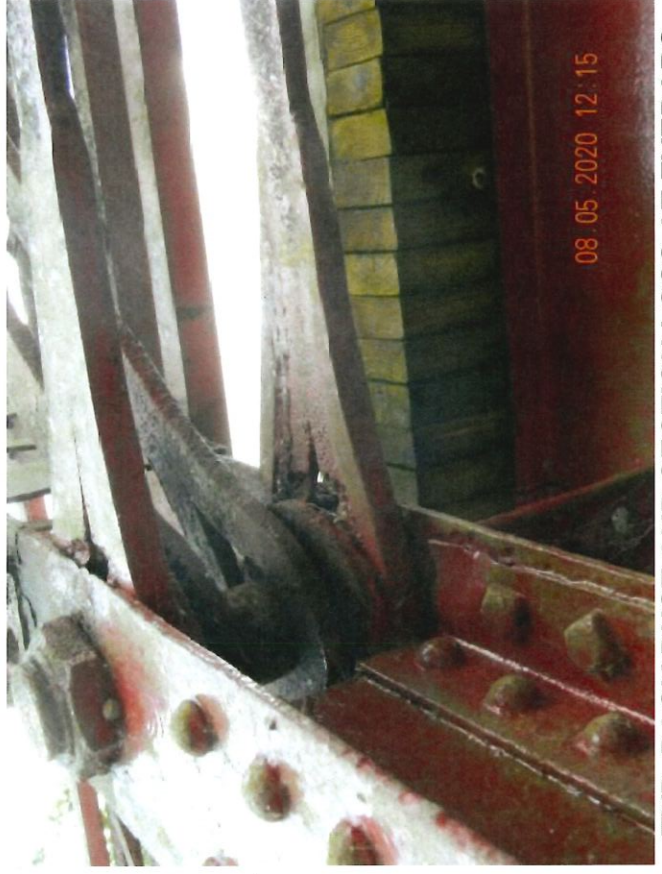
TYP. PACK RUST AND SECTION LOSS AT EYEBARS

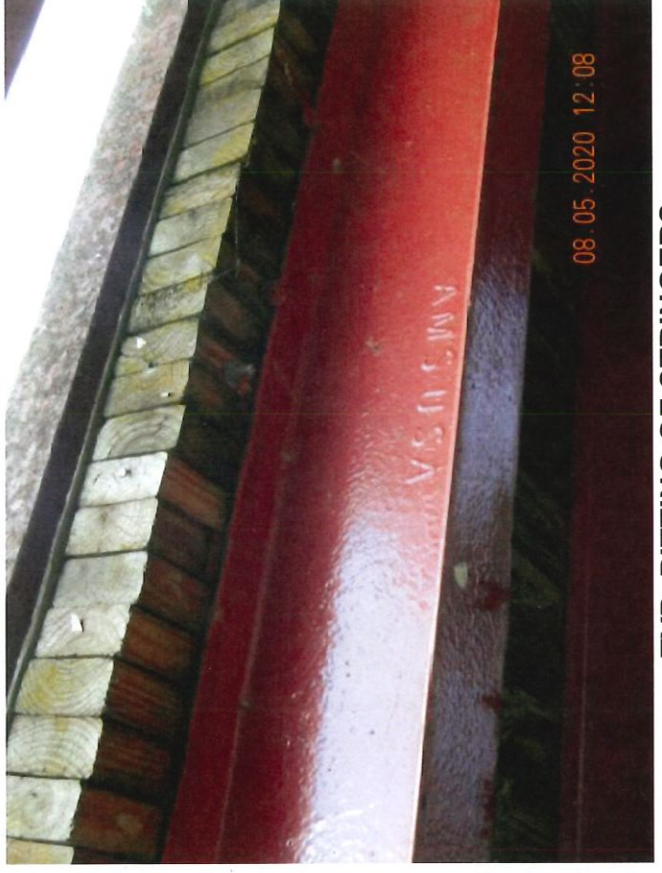
TYP. PITTING OF STRINGERS

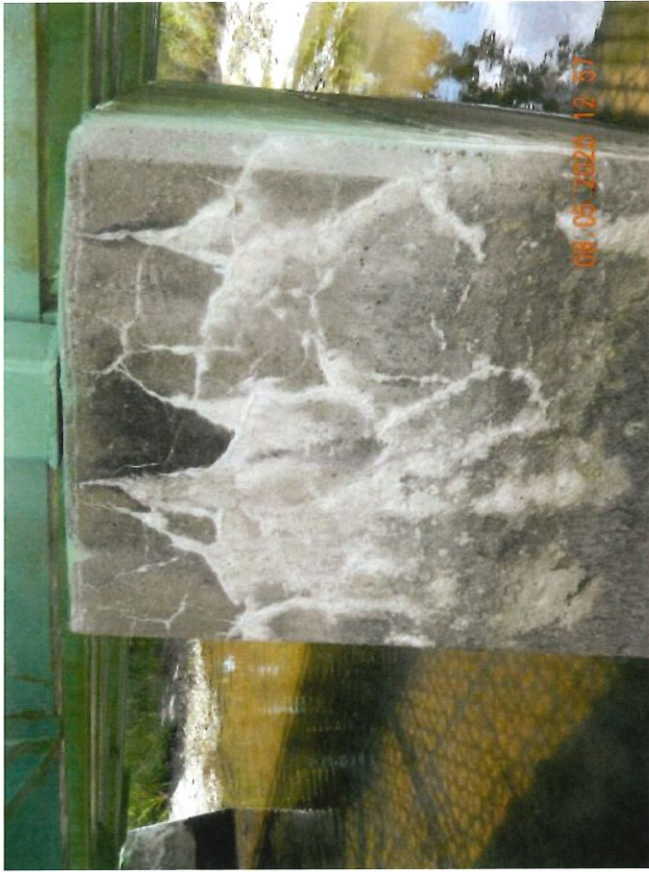
TYPICAL CRACKING WITH LEACHING AT PIERS

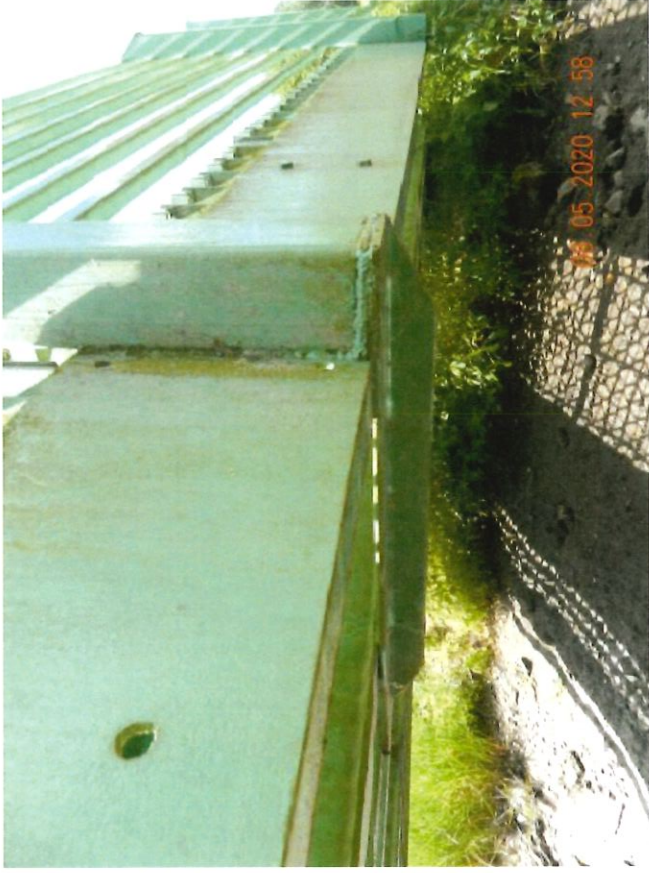
TYP. CONNECTION OF RAIL TO BEAMS

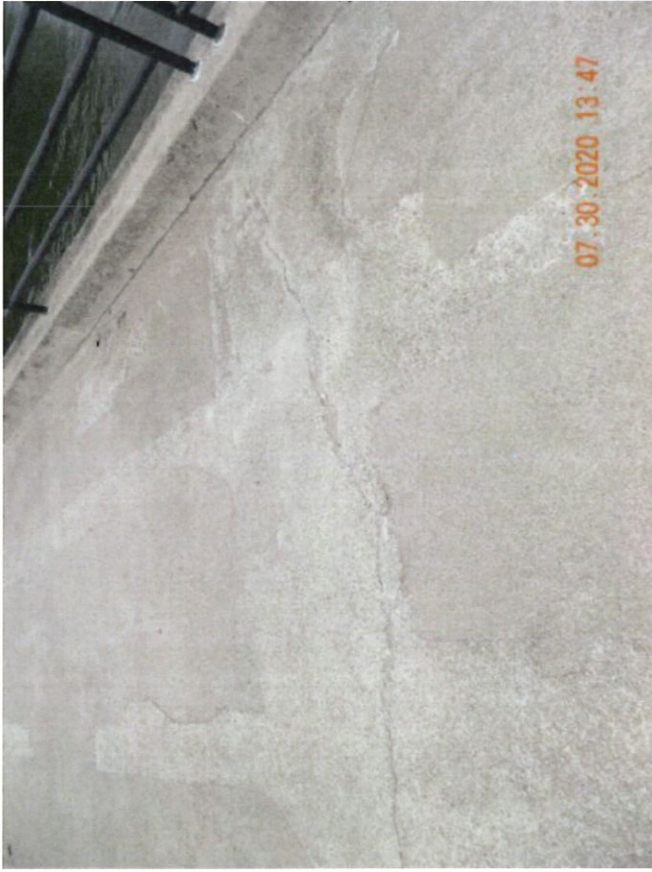
TYP. CRACKING IN DECK SURFACE

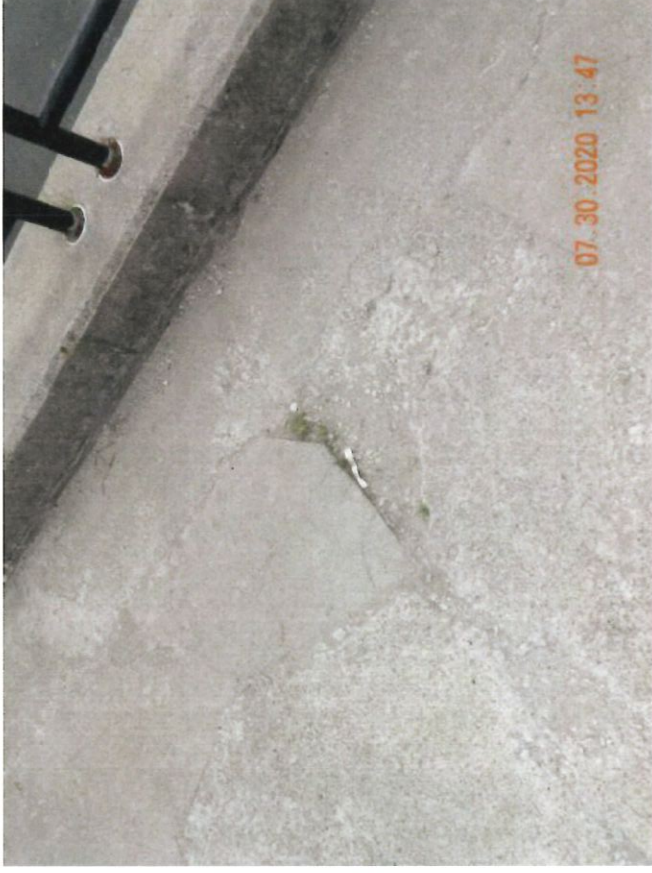
CRACKING AND SCALING IN DECK SURFACE

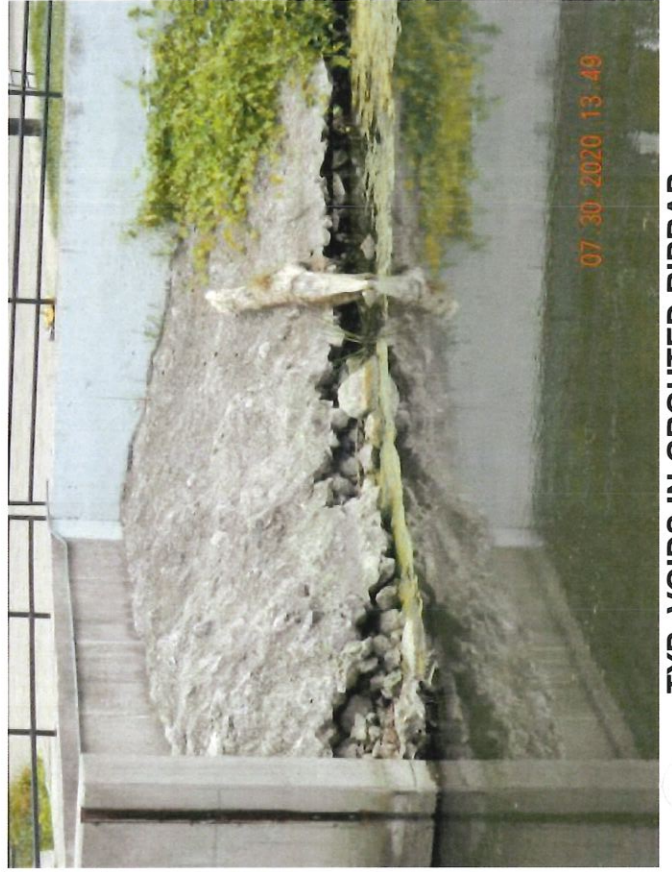
TYP. VOIDS IN GROUTED RIPRAP

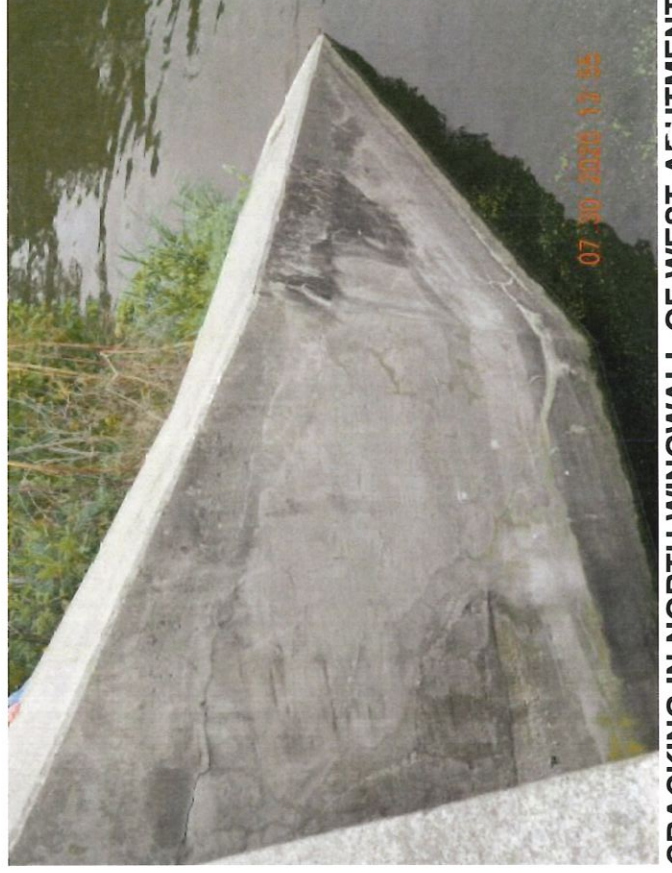
CRACKING IN NORTH WINGWALL OF WEST ABUTMENT

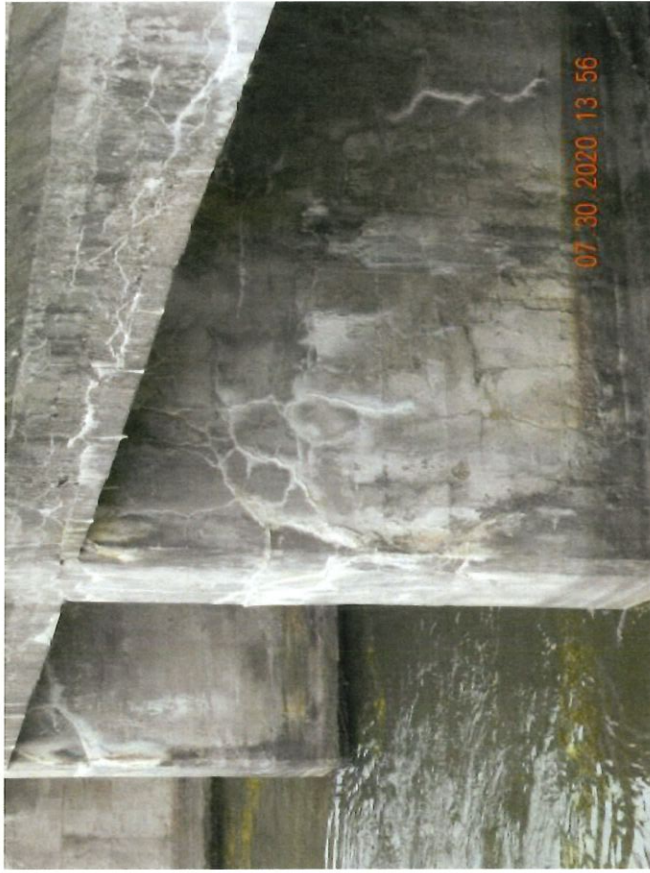
CITY OF GOSHEN BRIDGE NO. 306

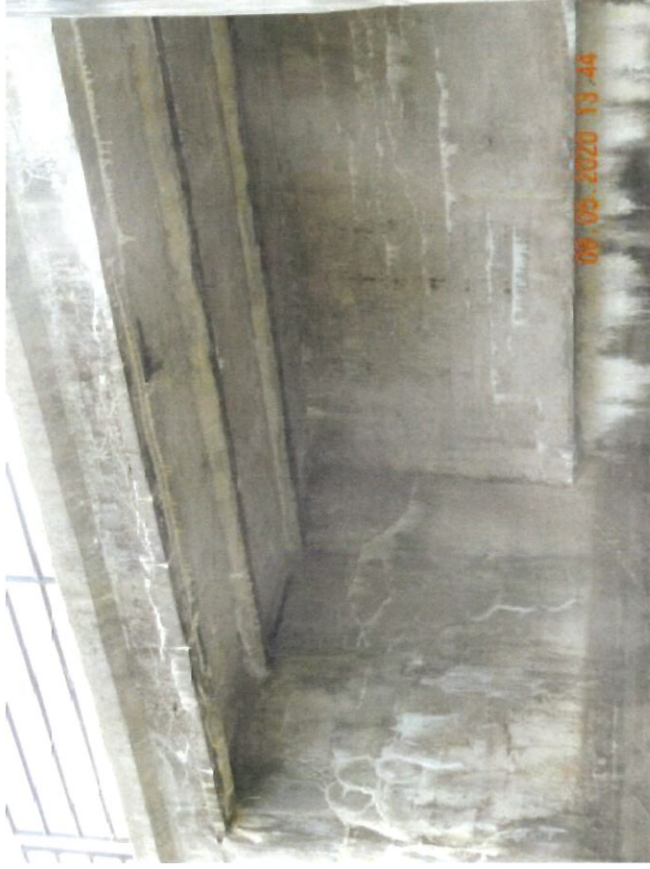
HEAVY CRACKING WITH LEACHING IN PIER WALLS

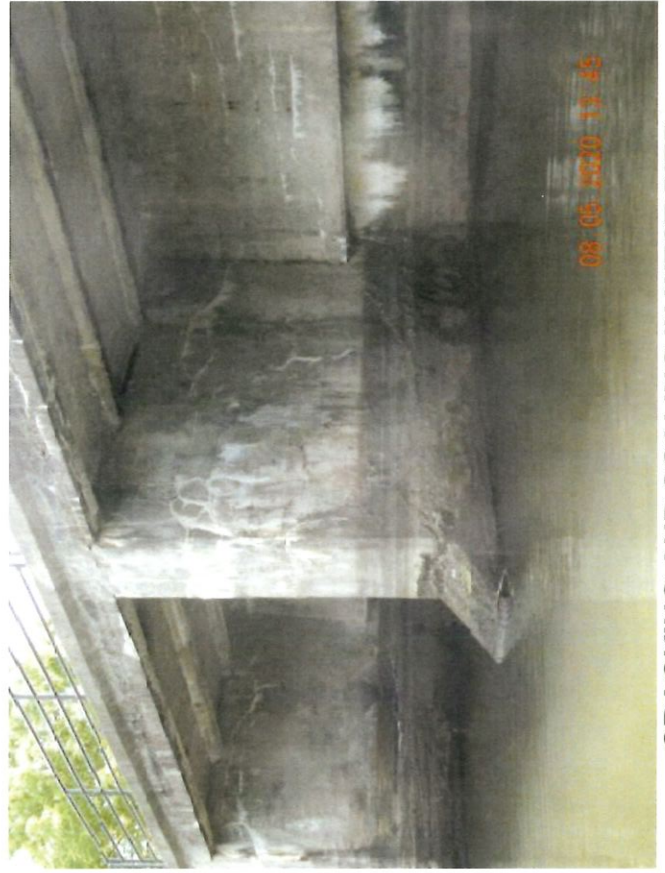
UNDERSIDE OF WEST SPAN

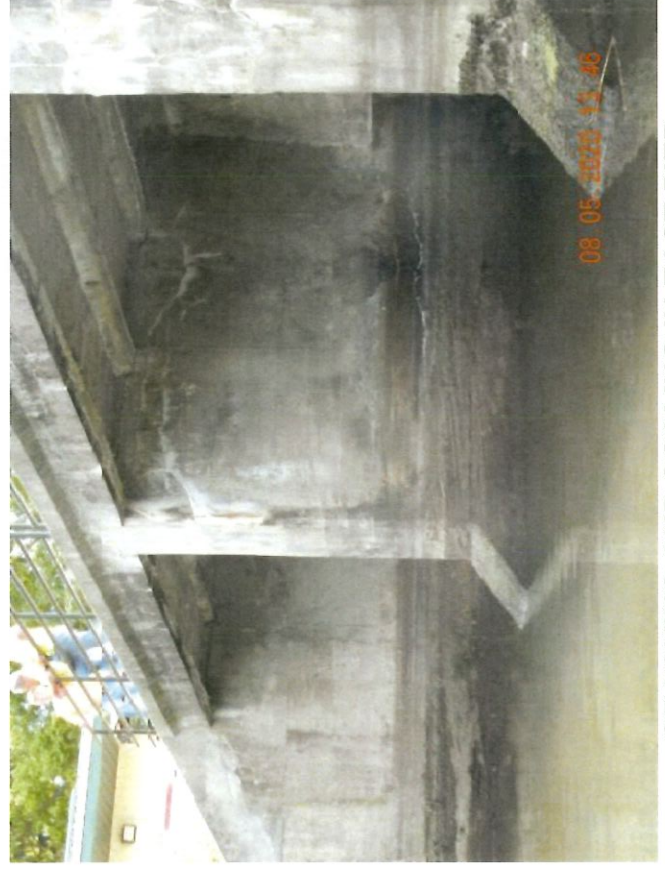
CRACKING AND SCALING IN WEST PIER

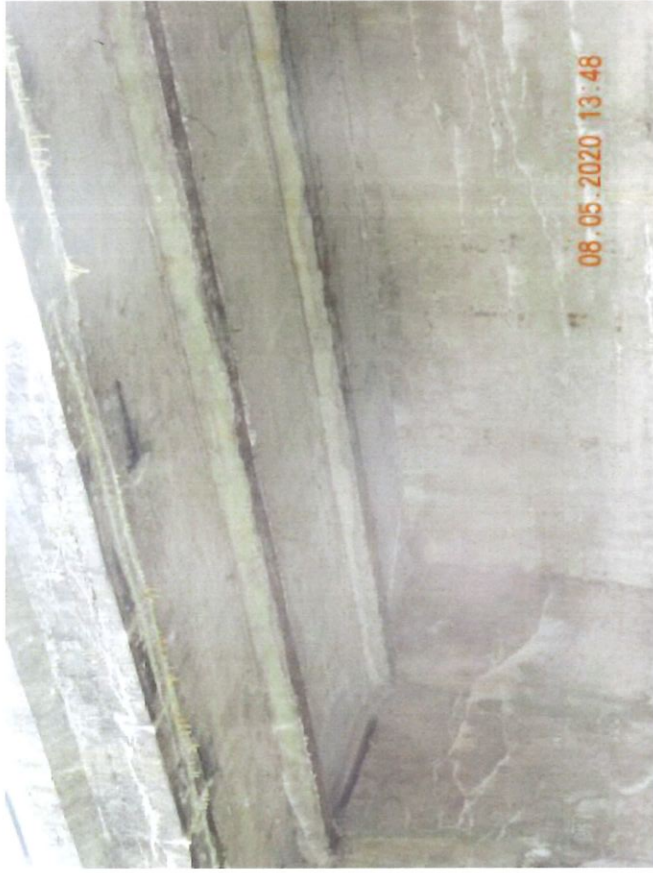
TYP. UNDERSIDE OF STRUCTURE

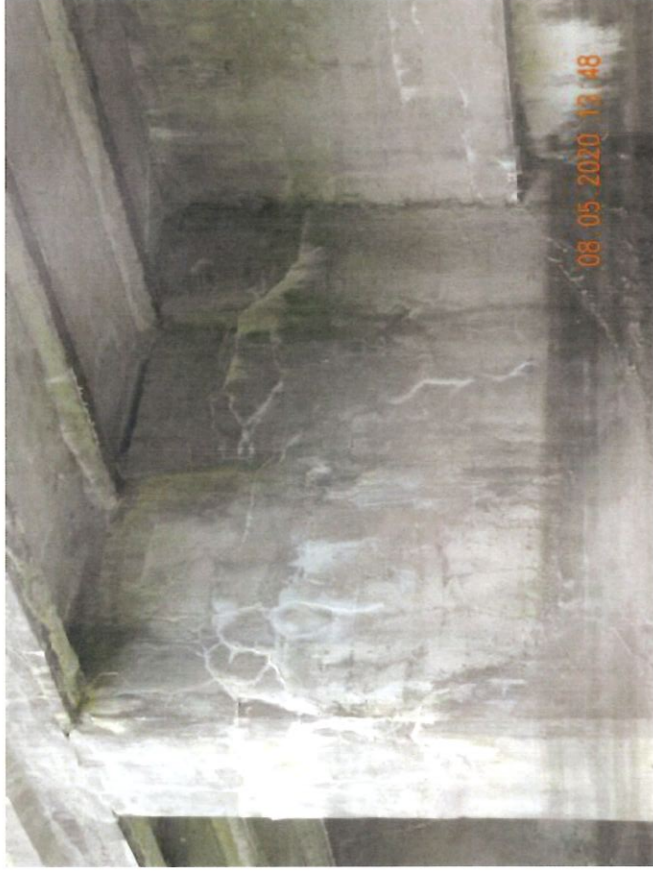
HEAVY CRACKING WITH LEACHING IN WEST PIER

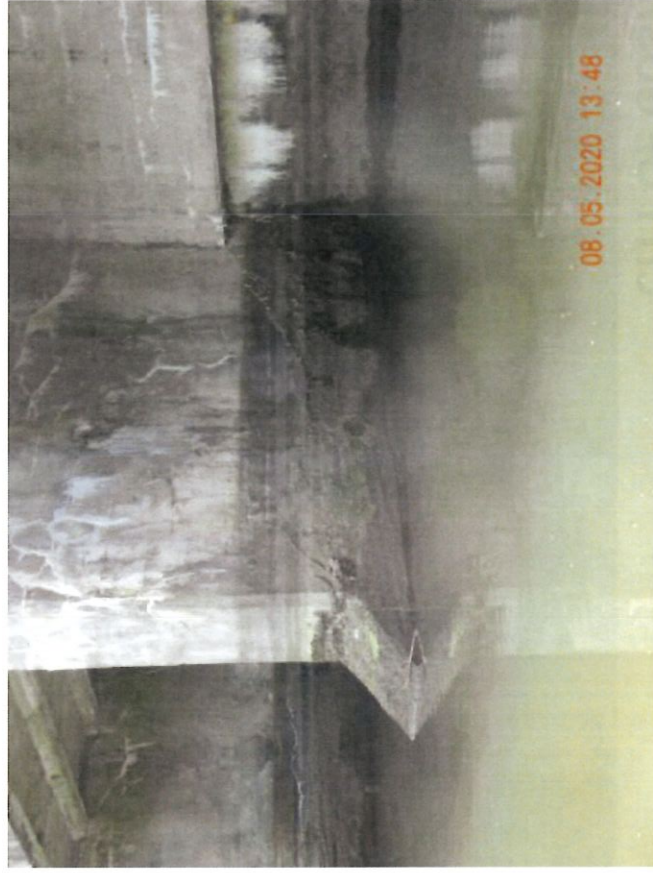
TYP. SCALING BELOW THE WATERLINE

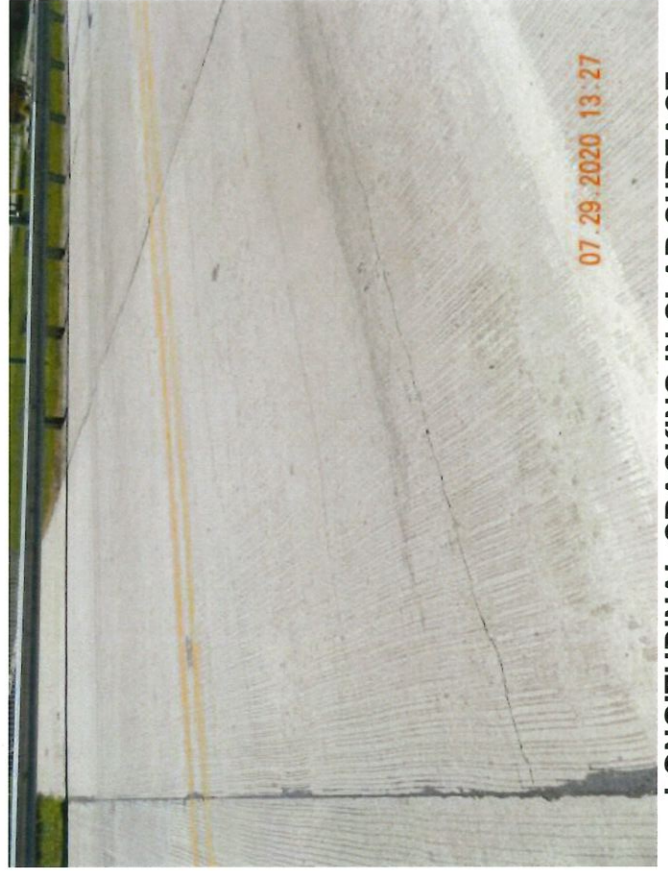
LONGITUDINAL CRACKING IN SLAB SURFACE

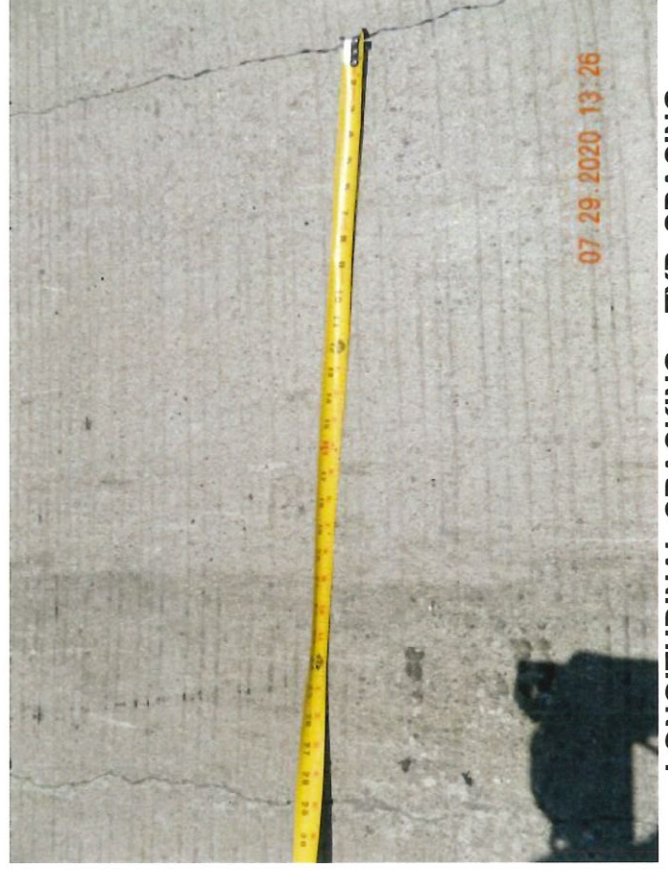
LONGITUDINAL CRACKING - TYP. SPACING

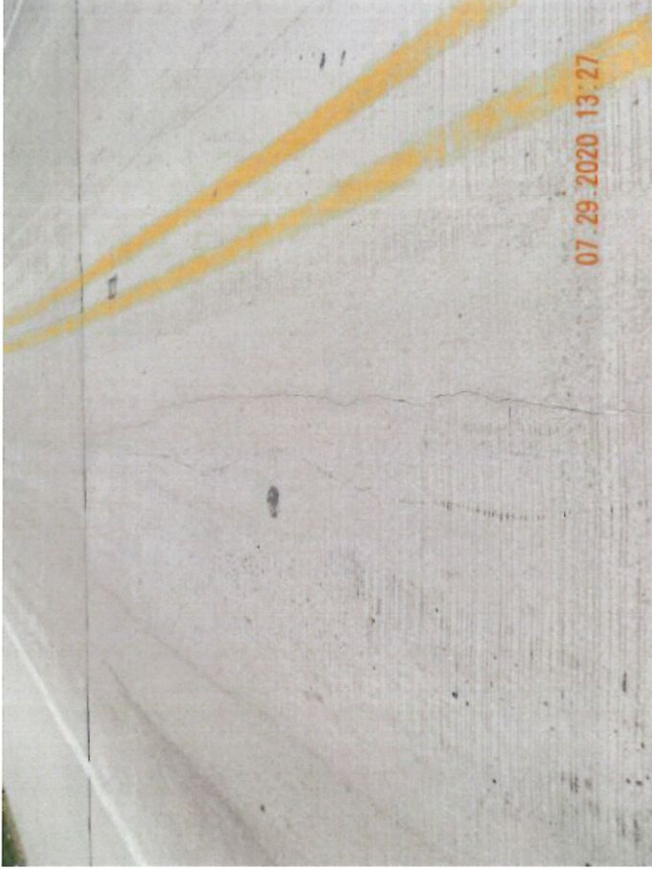
LONGITUDINAL CRACKING IN SLAB SURFACE

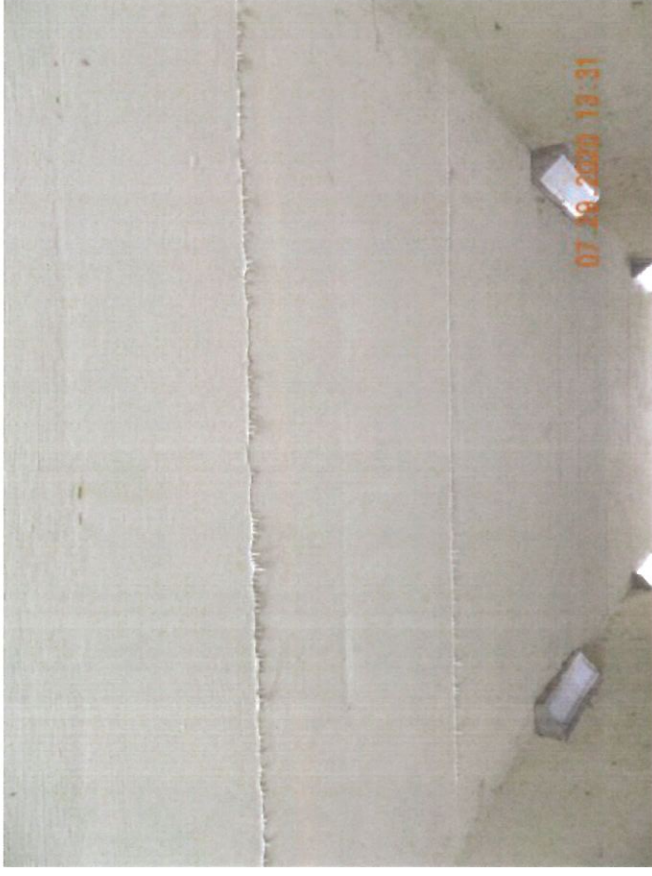
UNDERSIDE OF TOP SLAB W/ LONGITUDINAL CRACKING

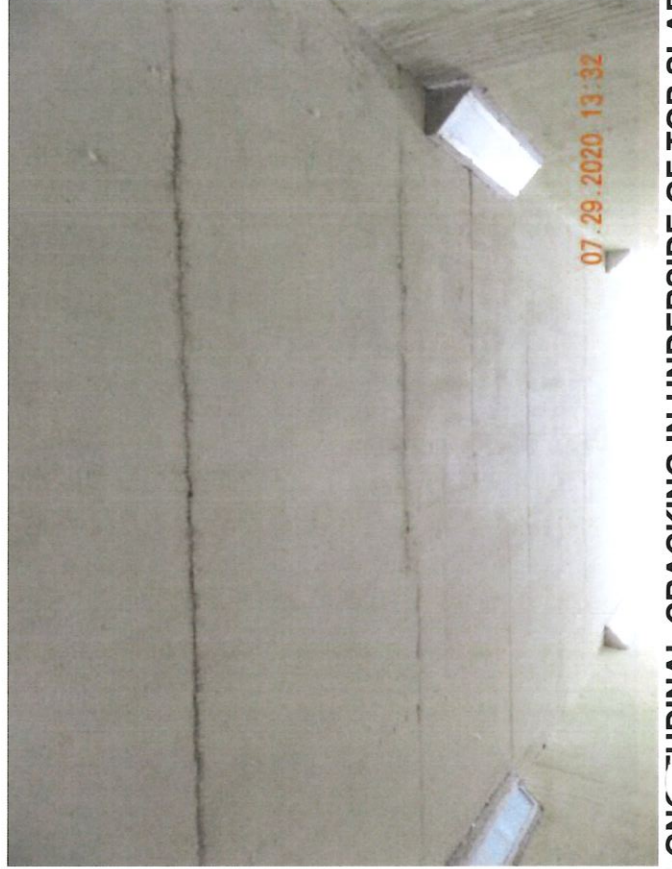
LONGITUDINAL CRACKING IN UNDERSIDE OF TOP SLAB
