BRIDGE INSPECTION REPORT CITY OF GOSHEN, INDIANA

PHASE I - 2020

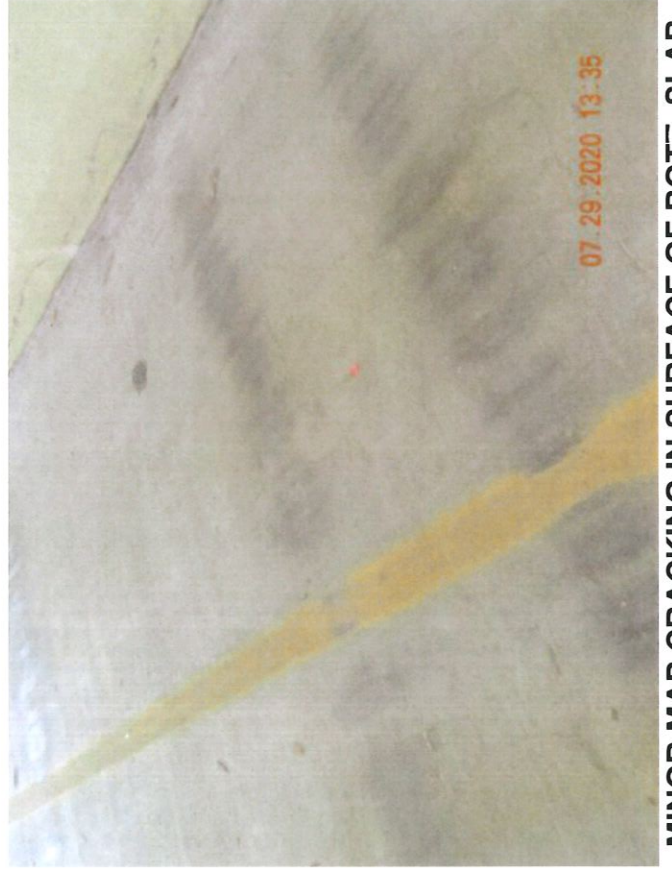
MINOR MAP CRACKING IN SURFACE OF BOT™ SLAB

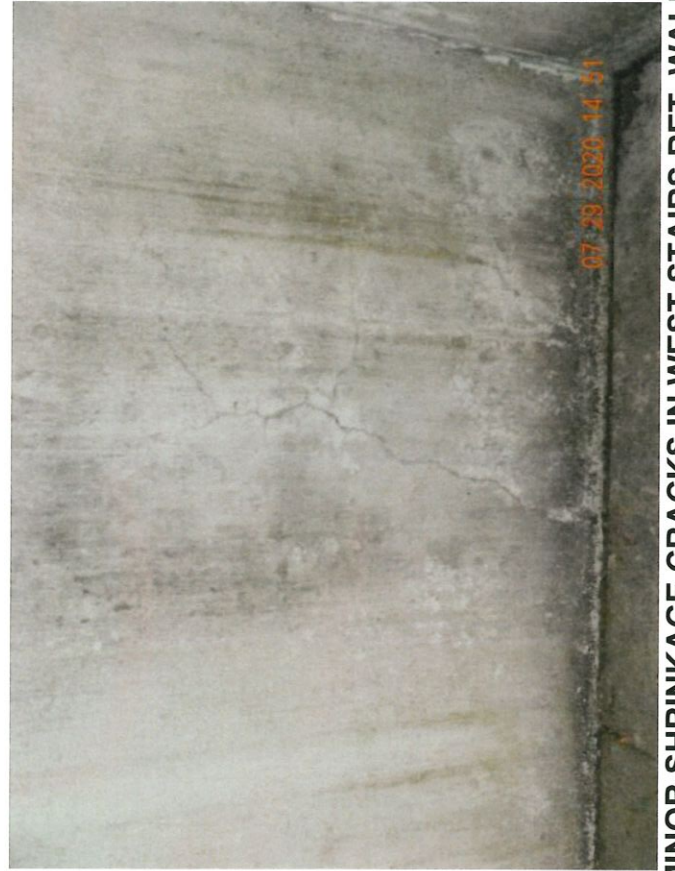
MINOR SHRINKAGE CRACKS IN WEST STAIRS RET. WALL

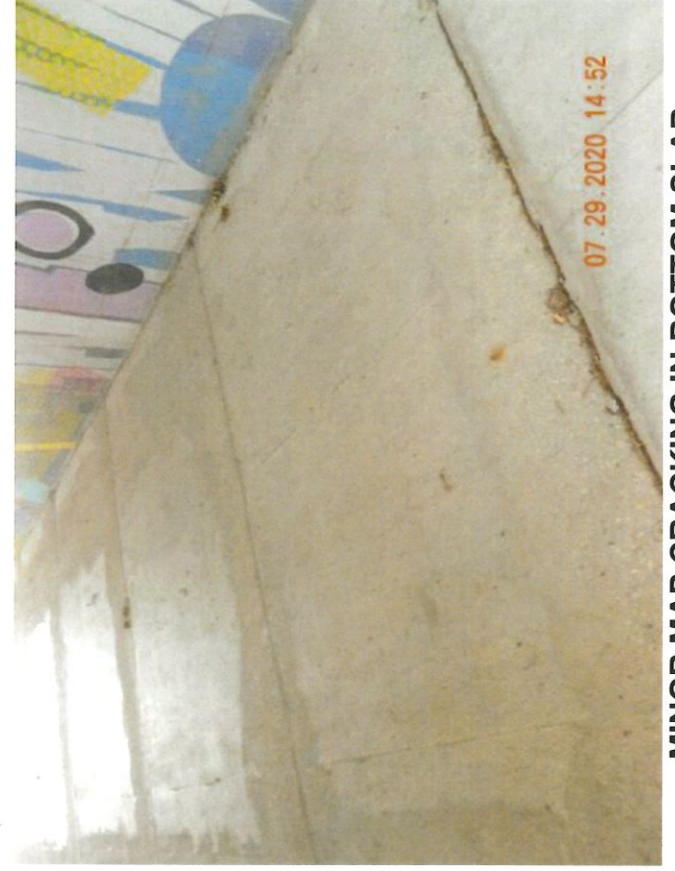
MINOR MAP CRACKING IN BOTTOM SLAB

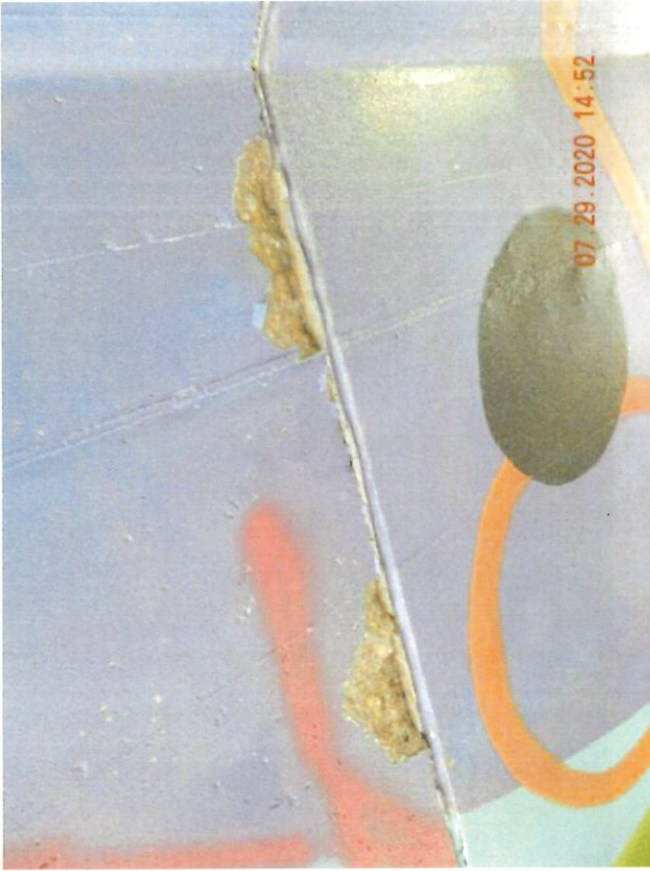
SURFACE SPALLS IN TOP SLAB OF UNIT 2 FROM WEST

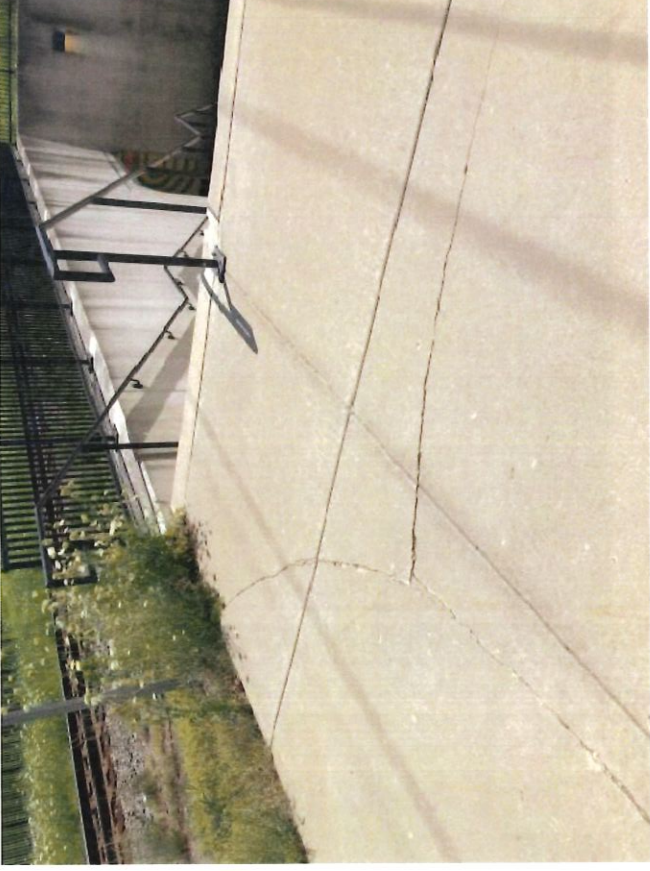
CRACKING IN SIDEWALK APPROACH AT WEST STAIRS
